# STONE MASONRY IN CLAY MORTAR with GABION BANDS

## GABION BANDS

Alternative to timber bands for masonry in mud mortar

A report submitted to the Nepal DUDBC by Randolph Langenbach,  
Conservationtech Consulting, [www.conservationtech.com](http://www.conservationtech.com)

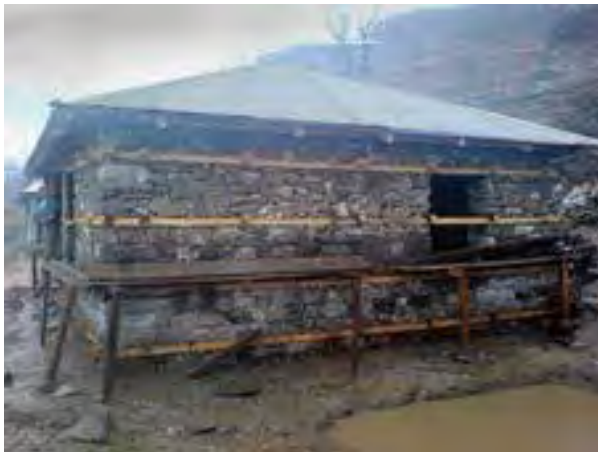
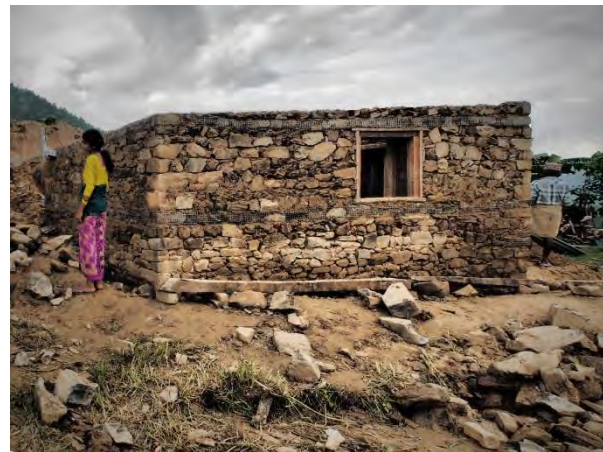
*left: House in Pakistan of bhatar construction being built after 2005 earthquake (photo by Tom Schacher for SDC). Right: Demonstration house with Gabion Bands at the Sunar Family Farm in Mankhu, Dhading District featured in TV documentary show Himalayan Megaquake.*

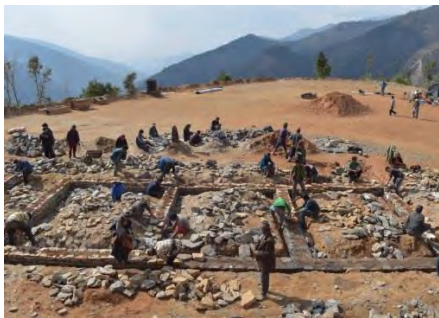
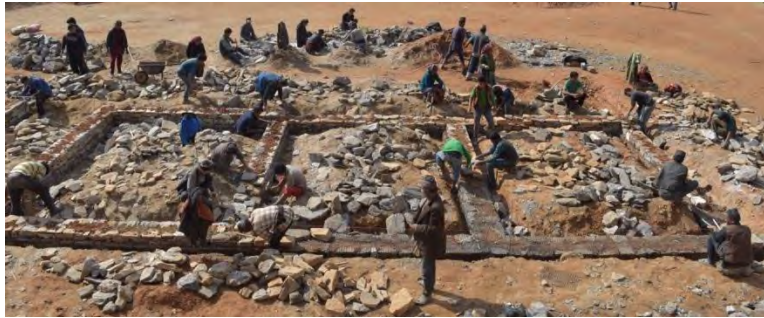
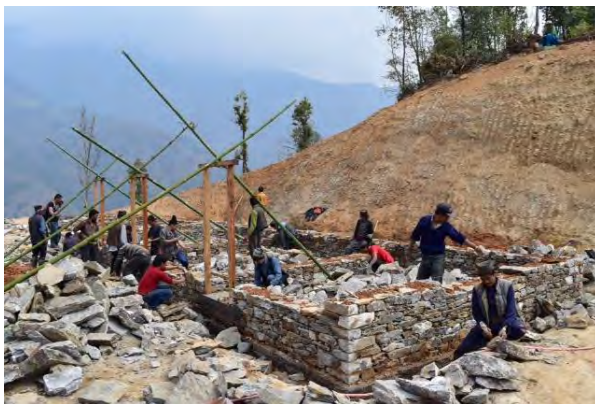
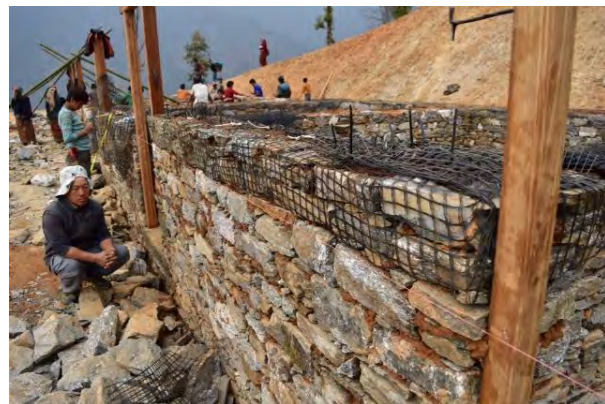
**Chupar School under construction with polypropylene Gabion Bands. (Photos by John Vavruska)**

Already underway are several other projects, one of which is being undertaken with the assistance of former Peace Corps volunteer, John Vavruska, at Chupar in Nuwakot District about 25 miles north of Kathmandu (photos below). In this site, he has secured polypropylene geogrid mesh instead of galvanized wire, and only recently, on 2<sup>nd</sup> of March 2016, he reported that *“The polypropylene Secugrid geogrid is easy to work with and has high tensile strength.”*

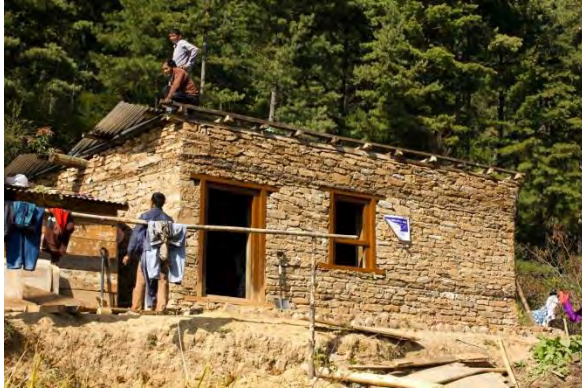
**New house with Gabion Bands in Jiri.**

I have learned of another house that was inspired by the Mankhu demonstration project that has already been constructed and finished in Jiri a village of 7,138 people in Dolakha District in the Janakpur Zone of north-eastern Nepal by a group called “Solar Wanderkino Nepal.” This project was undertaken by Kshitiz Pradhan (Civil Engineer) and Awas Thapa (Documentary filmmaker). The two photographs below show that project in Jiri.

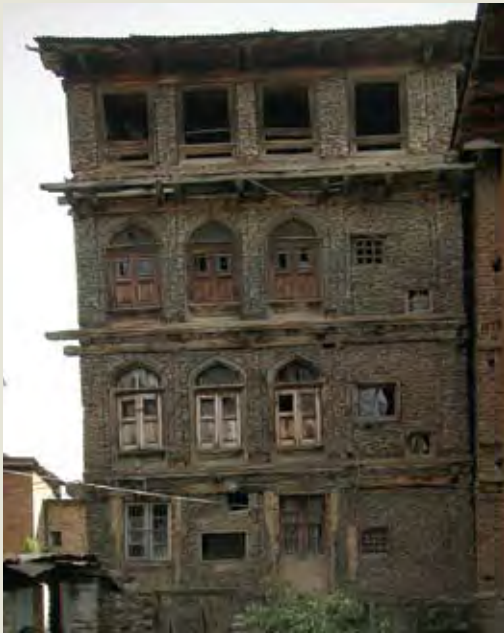
*TAQ*: TIMBER-LACED MASONRY  
BEARING WALL CONSTRUCTION

*Taq* construction is a composite system of building construction with a modular layout of load-bearing masonry piers and window bays tied together with ladder-like constructions of horizontal timbers embedded in the masonry walls at each floor level and window lintel level. These horizontal timbers tie the masonry in the walls together, thus confining the brick mud or rubble stone of the wall by resisting the propagation of cracks. The masonry piers are almost always 1 to 2 feet square and the window bay/alcove (*taqshe*) 3 to 4 feet in width. The *taq* modular layout defines the Kashmiri house size measurements, i.e. a house can be 3 *taq* (window bays) to 13 *taq* in width. In Pakistan, timber-laced masonry is known by the Pashto word *bhatar*.

Taq construction is a bearing wall masonry construction with horizontal timber lacing embedded into the masonry to keep it from spreading and cracking. It is usually configured with a modular layout of masonry piers and window bays tied together with ladder-like constructions of horizontal timbers embedded in the masonry walls at each floor level and window lintel level. The masonry piers are thick enough to carry the vertical loads, and the bays may either contain a window, or a thinner masonry wall as required by the floor plan and the building's orientation. The ladder-like sets of timber beams (*ker*) laid into the exterior and interior faces of the walls are connected together through the wall either by the floor beams (*veeram*) and joists or short connector pieces (see Figure 1.1h for a view of similar construction in Ahmedabad where the connector pieces are visible). These horizontal "ladder bands" are located at the base of the structure above the foundation (*das* or *dassa*), and at each floor level and at the window lintel level.

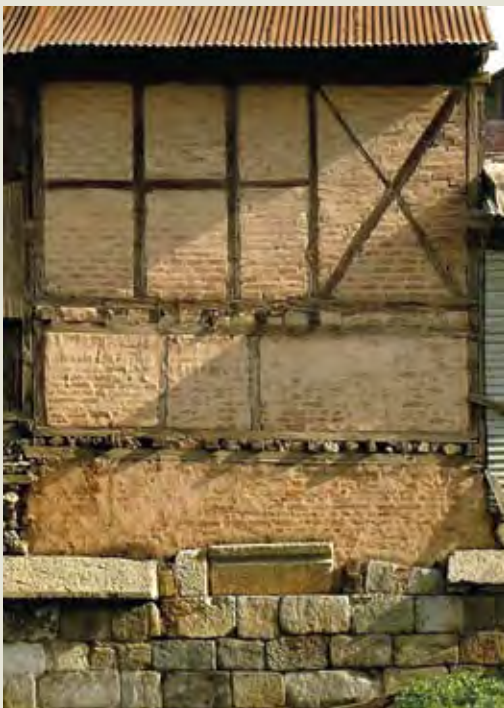
*DHAJJI DEWARI*: TIMBER FRAME WITH  
INFILL MASONRY CONSTRUCTION

*Dhajji dewari* is a timber frame into which one layer of masonry is tightly packed to form a wall, resulting in a continuous wall membrane of wood and masonry. The term is derived from a Persian word meaning “patchwork quilt wall”. The frame of each wall consists not only of vertical studs, but also often of cross-members that subdivide the masonry infill into smaller panels, impart strength and prevent the masonry from collapsing out of the frame.

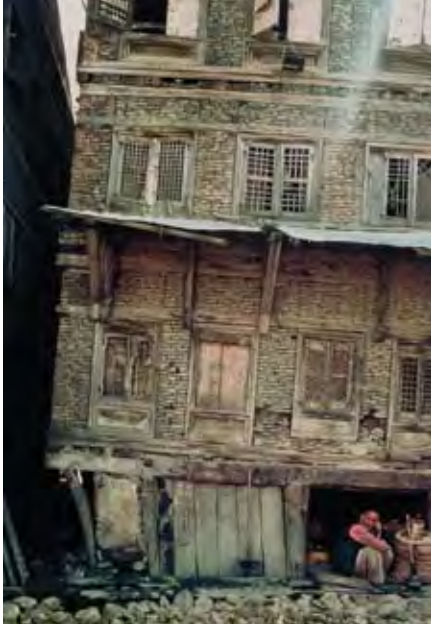
1.1a 18th- or early 19th-century canal shop house alongside what was once the Mar Canal in Srinagar. This building survived the 1885 earthquake. The timber lacing has held this structure together despite extensive differential settlement. Note that the windows are not lined up vertically: this feature would not be structurally possible had the walls not been reinforced with timbers.

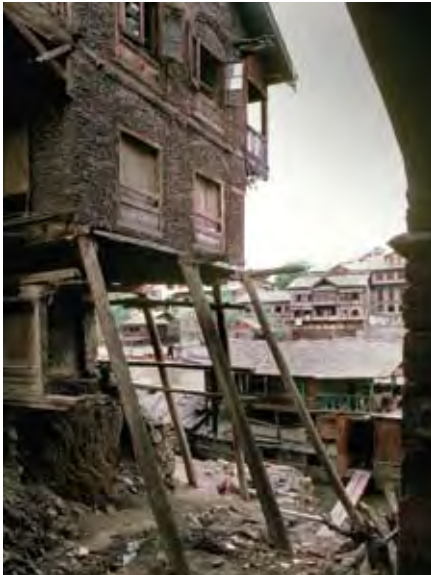
1.1b Taq building on the bank of the River Jhelum. The fact that this bearing wall masonry structure can be held up on three poles is a testament to the effectiveness of the timber lacing. The shoring poles are supporting the structure under the three main beams that support the joists, two of which are embedded in the front and back masonry walls.

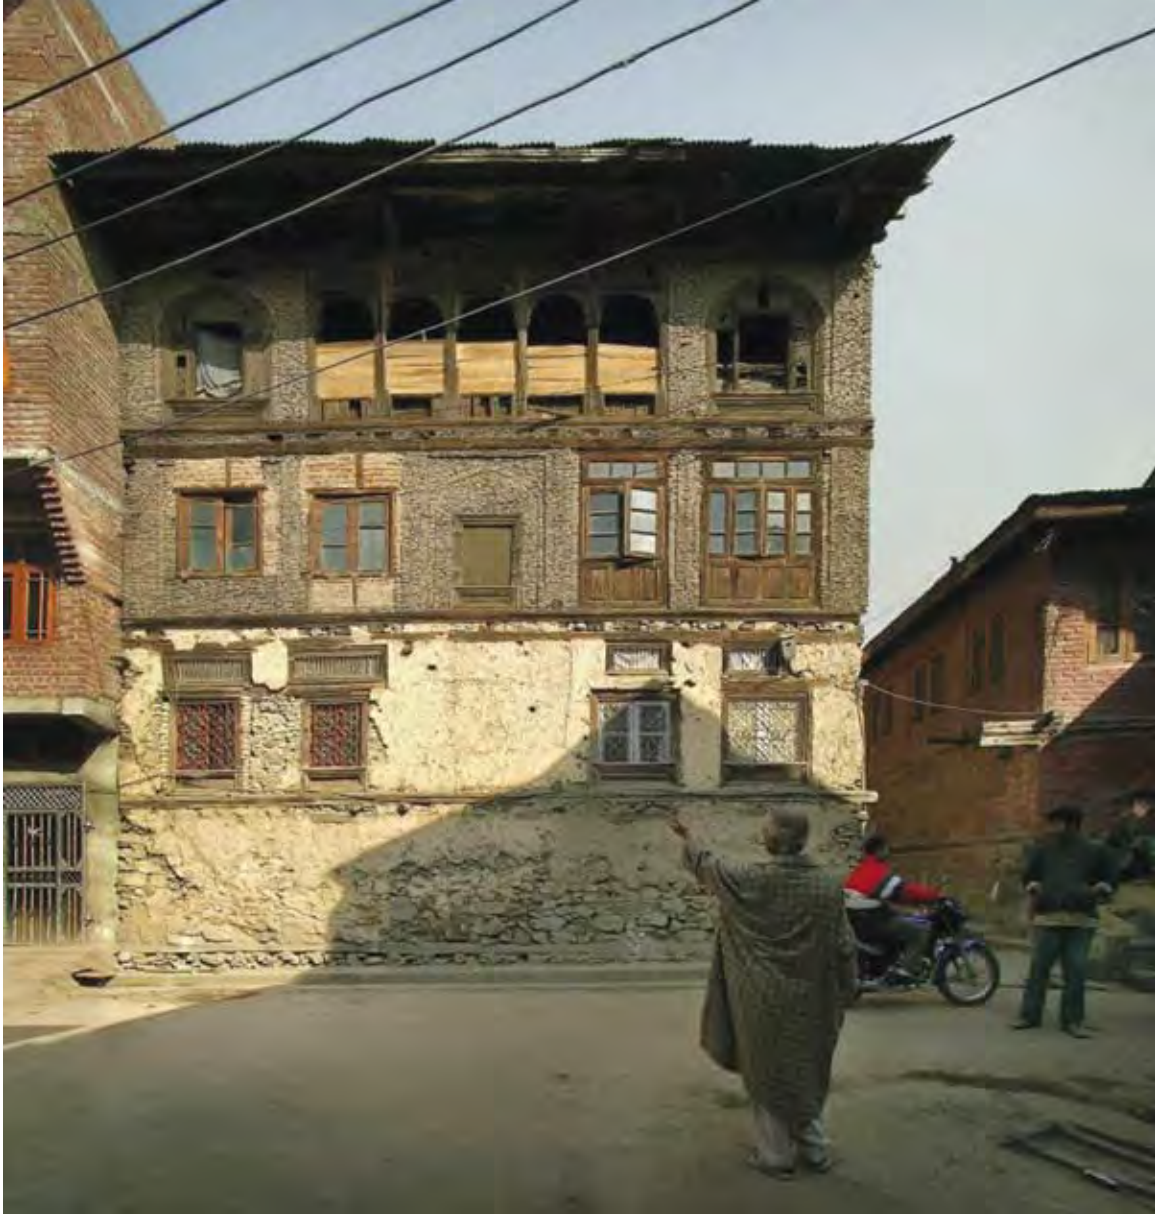
*1.1c Taq construction in Srinagar. The symmetrical layout of windows is characteristic of taq and it is from this that the name of the construction system is derived.*

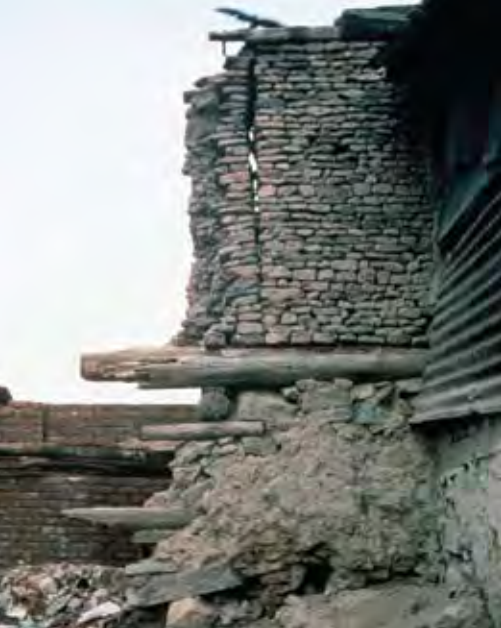
1.1d House under demolition showing how the masonry wall of taq is subdivided into panels where the light shows through between the wall panel and the half-demolished pier.

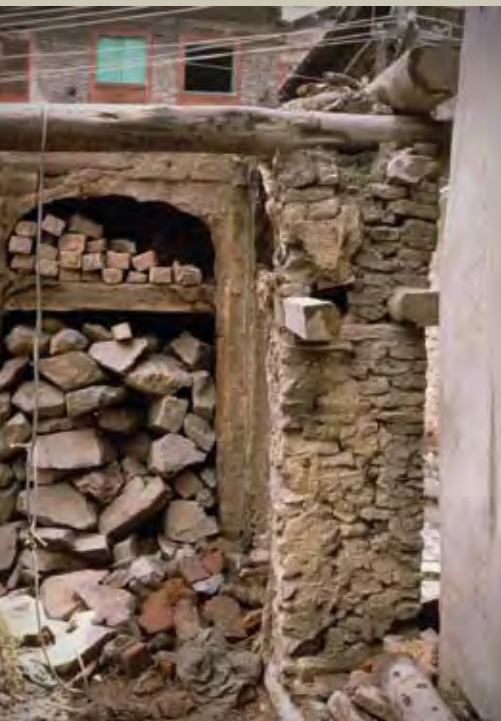
1.1e Photograph taken in the 1980s showing a building under demolition with taq timbers visible at the window lintel level and at the floor level. The floor joist can be seen to penetrate the wall where it is sandwiched between the exterior runner beams.

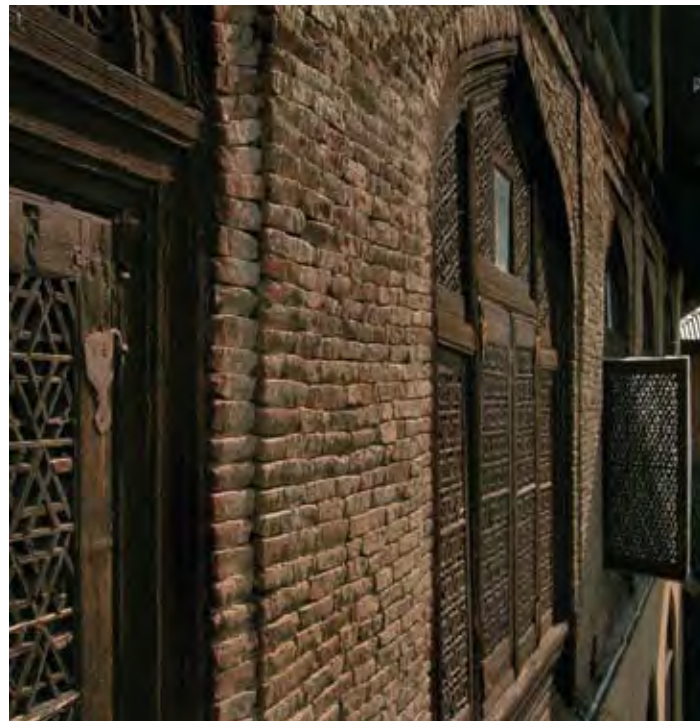
1.1f View of the mid-19th century Jalali Haveli in Srinagar showing Maharaji bricks. Maharaji bricks, common in the 18th to early 20th centuries, were shaped without the use of a wooden mold and thus are of varying length and about 1 inch (2.5 cm) in thickness.

The face bricks traditionally used during the 19th and early 20th centuries were small in size, rough-surfaced, and hard-fired (Figure 1.1f). They are known as Maharaji bricks because the Maharaja of the Dogra period (1846–1947) monopolized their production. They served as the weather-resistant skin over sun-dried brick (known locally as *khaam seer*) or rubble made up of broken bricks laid in clay mortar (Hamdani, 2006).

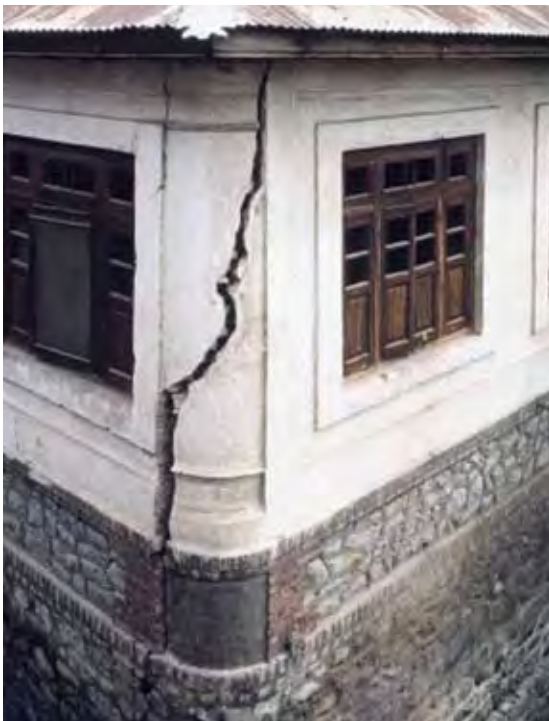
1.1g Photograph taken in the 1980s in Srinagar of an unreinforced masonry building without timber lacing, showing how soil subsidence is causing the structure to come apart.

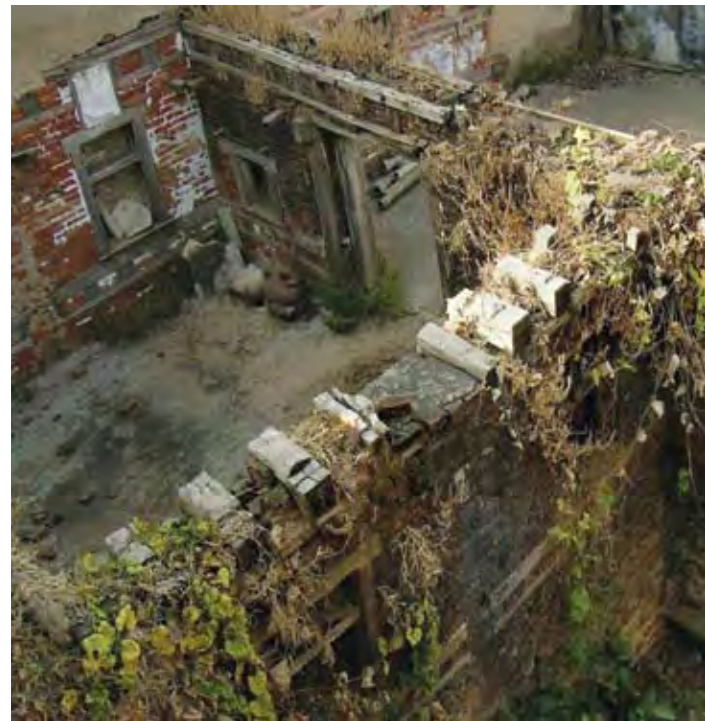
1.1h View of partially demolished 18th- or 19th-century dwelling in Ahmedabad, Gujarat, with timber lacing like that found in Kashmir. This view shows the cross-pieces that tie the inside and outside runner beams laid into the masonry wall together. (A view of the peg holding one of these crosspieces is shown in Figure 2.3.3a.)

1.1i A model showing the typical “ladder bands” of timber runners and crosspieces found embedded in the masonry walls in traditional *taq* construction. At the floor levels, the joists run through the wall, and another pair of runner beams rests on top of the joists. At the window lintel level, shown in between, the timbers are tied together with cross pieces like those that can be seen in the Ahmedabad example in Figures 1.1h & 2.3.3a.

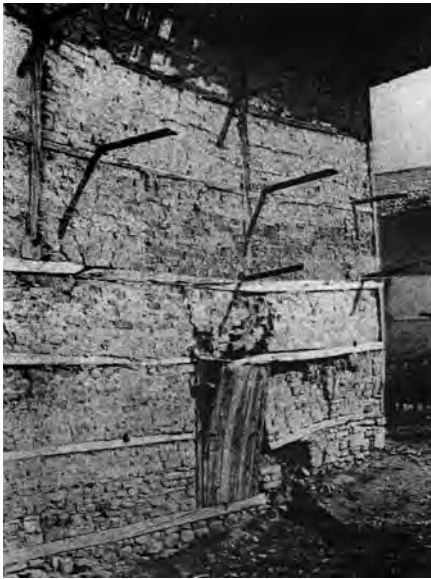
3.2a Photo by Turkish Professor Alkut Aytun showing a two-storey brick house with timber bond beams spanning the ground rupture from the 1970 Gediz earthquake in western Turkey. In the caption to this image, he observes that this shows the effectiveness of timber bond beams for both fired or unfired brick masonry (Aytun, 1981).

photo of a house that spanned the fault rupture in the 1970 Gediz earthquake, where the timber lacing held the masonry bearing wall together despite approximately 50cm of vertical ground displacement (Aytun, 1981) (see Section 2.2.4).

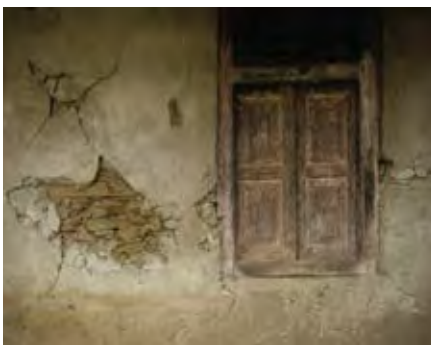
3.2b The side of a timber-laced masonry building near Uri after the 2005 earthquake: The quake caused the cracking of the modern rigid cement plaster from the otherwise non-destructive shifting of the underlying timber-tied masonry.

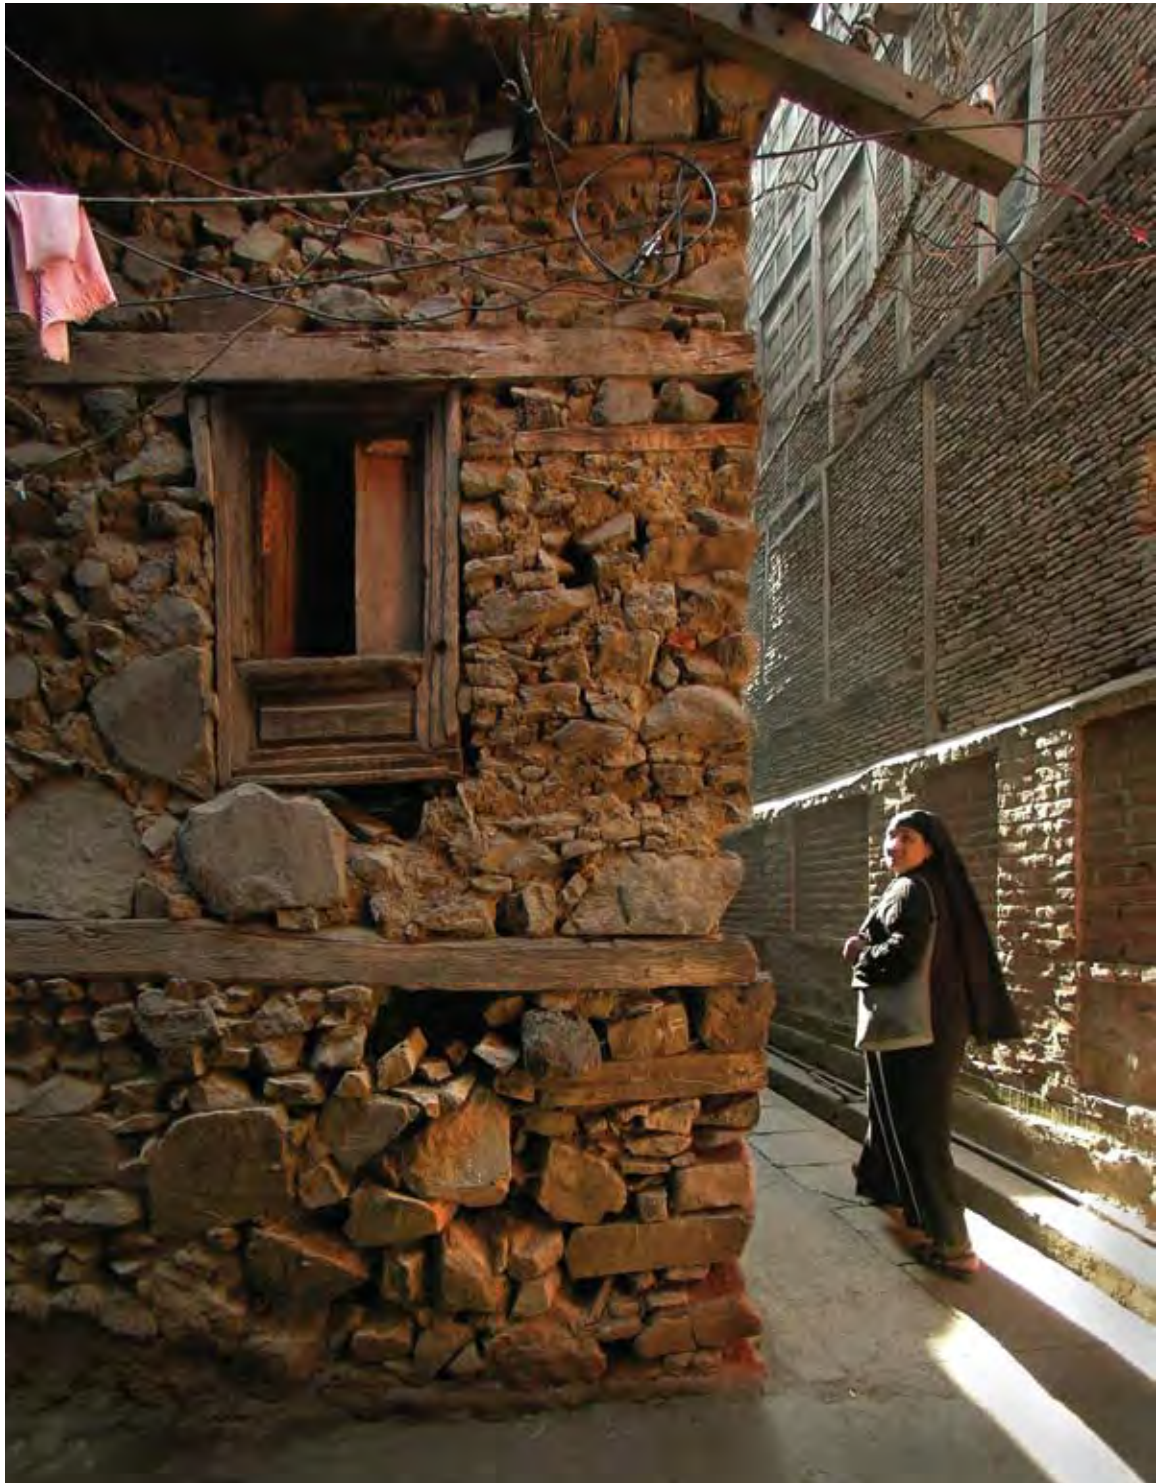
*3.2e While most taq buildings in Srinagar are constructed of fired brick, the lower storeys of this large house are of stone and do not observe the modular window bay layout from which the term taq is derived. Timber-laced stone construction is more common in Baramulla and the surrounding rural mountain areas further to the west.*

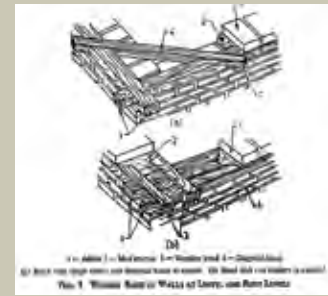
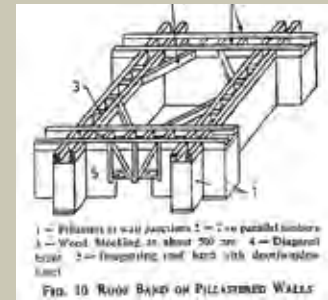
(1) Illustrations from *IS 13827* showing timber lacing recommended for earthen buildings.

(2) Illustration from *IS 13828* showing timber lacing recommended for low-strength masonry buildings.

(3) Illustration from 2005 *Guidelines for Earthquake Resistant...Masonry Buildings in... Kashmir* showing recommended use of timber bands in stone masonry buildings.

The most recent Indian codes date from 1993. A modified form of *taq* construction can, as mentioned above, be found in the Indian Standard Building Codes *IS 13827: Improving Earthquake Resistance of Earthen Buildings – Guidelines*, and *IS 13828: Improving Earthquake Resistance of Low-Strength Masonry Buildings – Guidelines*. Low-strength masonry “includes fired brick work laid in clay mud mortar and random rubble; uncoursed, undressed or semi-dressed stone masonry in weak mortars; such as cement-sand, lime-sand and clay mud”. (The inclusion of the word “guidelines” in the titles of these codes is emblematic of the fact that for the most part, building codes in India remain advisory documents, rather than mandatory rules, and also a recognition of the fact that these particular codes address types of rural construction for which it would be difficult to enforce mandatory rules in any case.)

After the 2005 Kashmir earthquake, the Government of India, Ministry of Home Affairs gave further recognition of variants of the traditional Kashmiri systems by including them in their publication that followed the earthquake, *Guidelines for Earthquake Resistant Reconstruction and New Construction of Masonry Buildings in Jammu and Kashmir State* (Arya and Agarwal, 2005). The two 1993 codes and the 2005 post-earthquake manual all specify that seismic bands (also known in English as tie beams, ring beams or bond beams) are recommended for use in new masonry construction. The timber versions of these bands shown on page 14 of the 2005 *Guidelines*, and in *IS 13828*, Section 8 are very similar to what has existed in *taq*, *bhatar*, and *hatil* timber-laced construction for centuries.

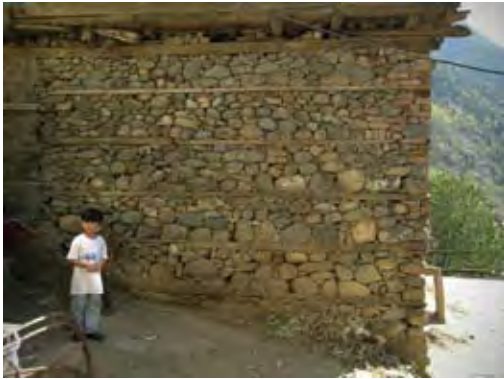
3.3b Traditional bhatar construction in the Swatt Valley town of Behrain used to stabilize a rounded random rubble stone wall construction which otherwise is extremely at risk in earthquakes.

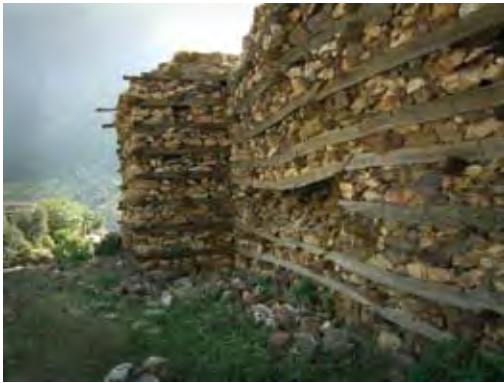
3.3c Early 20th-century fort in Besham, Pakistan after the 2005 earthquake, showing how the collapse of this dry-laid rubble stone wall was prevented by the timber lacing. This demonstrates the effectiveness of the timber tie beams (bhatari) in holding the earthquake-damaged rubble stone wall together.

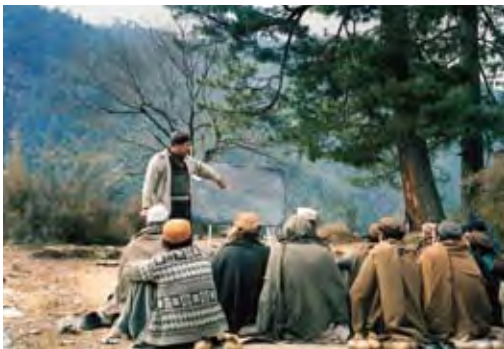
3.3d Training of craftsmen and owner-builders in a rural area of Pakistan Administered Kashmir. Photo by SDC.

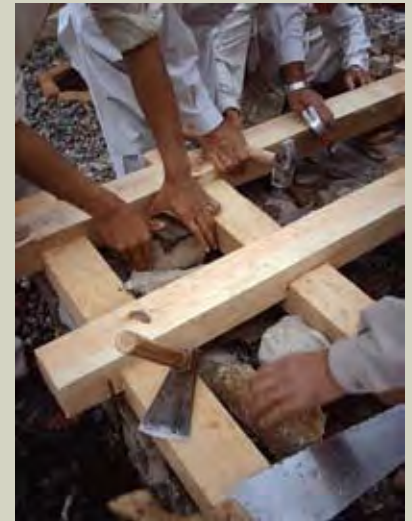
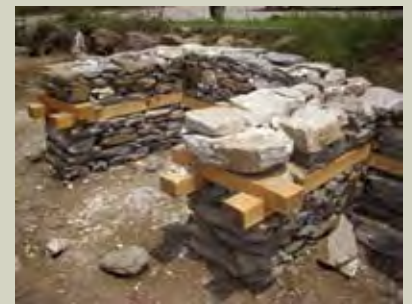
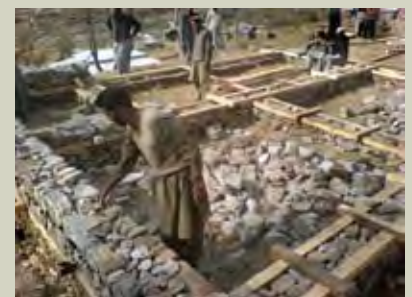
3.3e, f & g Views of a training workshop on bhatar construction for local masons in Battagram, Pakistan, in spring and summer 2007, prepared by the French Red Cross with Architectes et Développement. Photos by the French Red Cross.

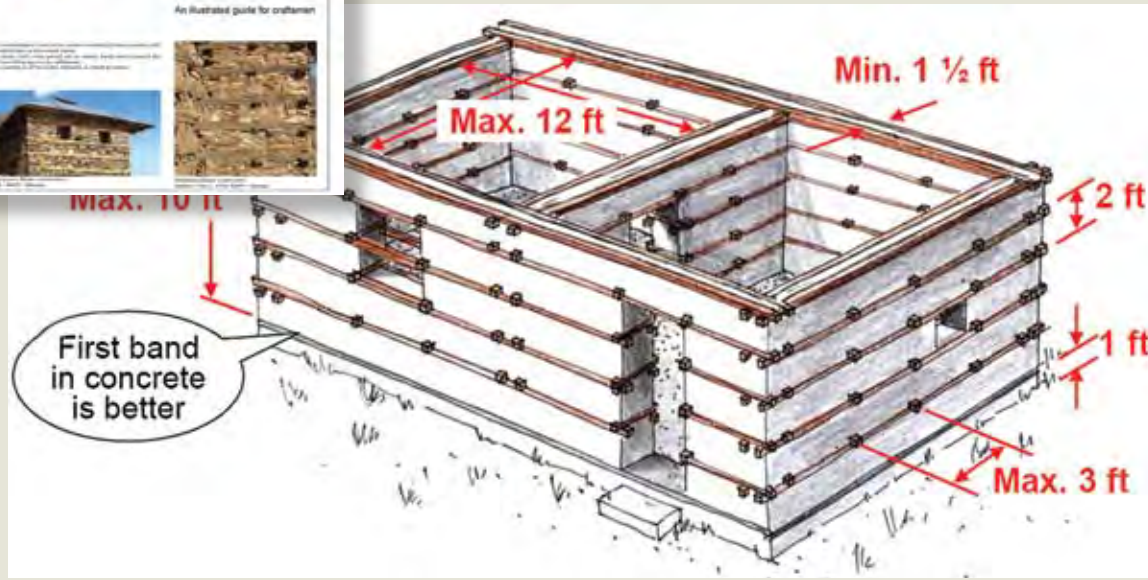
3.3h Drawing from the training manual *Bhatar Construction, an Illustrated Guide for Craftsmen*. This manual was created by Swiss Architect Tom Schacher of SDC and published by the Government of Pakistan for use in the training of rural craftsmen for the reconstruction of earthquake-damaged homes. Source: Tom Schacher and ERRA, Government of Pakistan.

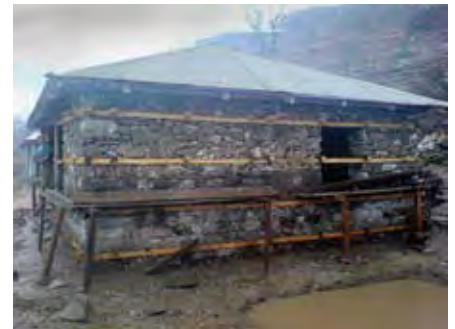
3.3i & j Completed building with *bhatar* following the Pakistani government-endorsed guidelines constructed by SDC as a demonstration of approved *bhatar* detailing. Photos by Tom Schacher, SDC.

*Taq* construction has largely gone out of use in Indian Administered Kashmir for new construction, but in Pakistan's Northwest Frontier Province, however, new buildings with *bhatar* and *cator* and cribbage construction continue to be constructed, particularly since the 2005 earthquake focused renewed interest on the seismic resistance of these systems – especially in preference to plain rubble stone without timber lacing, which had been commonly used in rural areas until the earthquake. In addition, *bhatar* has been successfully reintroduced into remote areas of Pakistan Administered Kashmir after the earthquake (see Figures 3.3i & 3.3j and 5.5h & 5.5i).

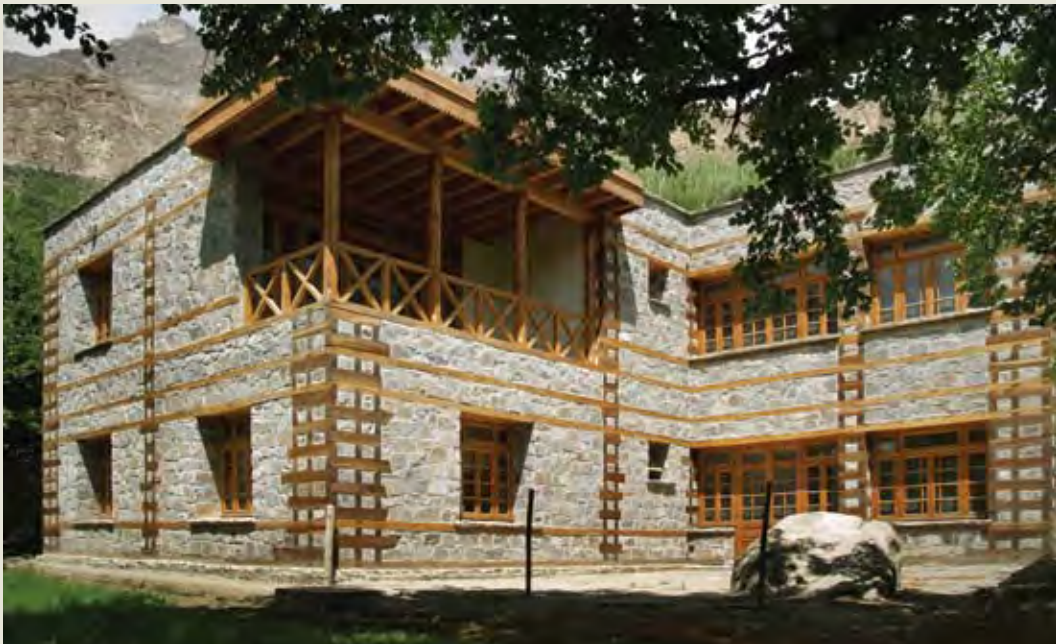
5.5h A new house with cator and cribbage timber lacing. The Balti word cator has the same meaning as the Pashto word bhatar. The regional difference is to have the extra reinforcement provided by the cribbage in the corners. This house was constructed for the former owner of the historic Altit Fort by the Aga Khan Cultural Services Division. Photograph by Tom Schacher, Swiss Agency for Development and Cooperation (SDC).

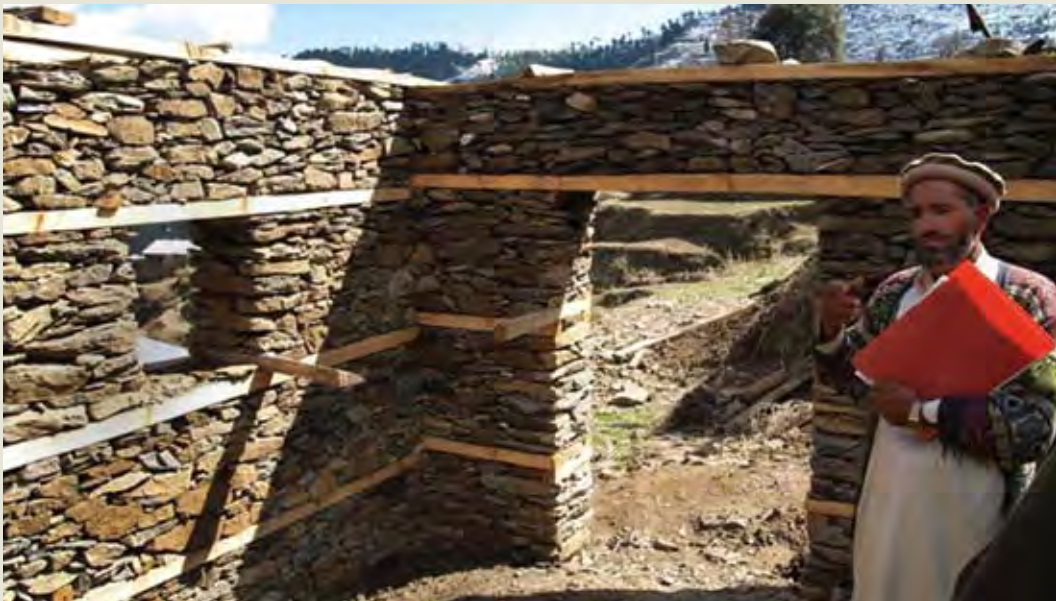
5.5i This new barn of bhatar with dry-laid stone masonry construction is in a mountain village near Battagram (in Gari Nuwab Said) in the Northwest Frontier Province of Pakistan. The site is remote from the road, one hour by car, then another half-hour by foot away from Battagram, making reinforced concrete construction impossible. Photograph taken in 2007 by Tom Schacher, Swiss Agency for Development and Cooperation (SDC).

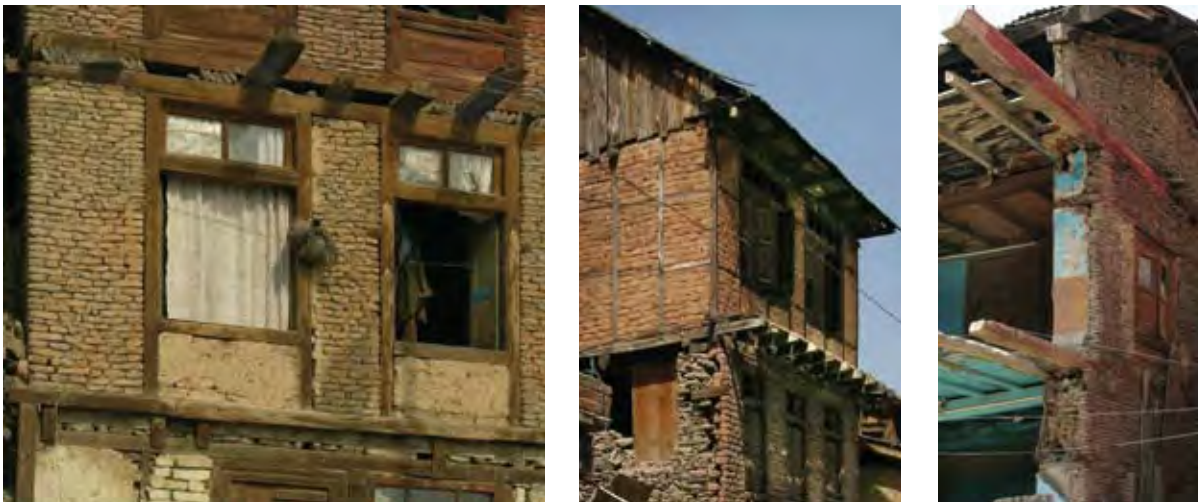
3.6.1 a, b & c Photographs showing construction details of *taq* buildings. The one on the far left shows the front wall perpendicular to the joists in a *taq* building, showing how the joists are sandwiched between the timber bands. The second shows how the secure connection of the joists to the front wall bridged the earthquake-collapsed rubble-stone side wall. The third show a *taq* building partly demolished, exposing the timber lacing in the wall parallel to the joists.

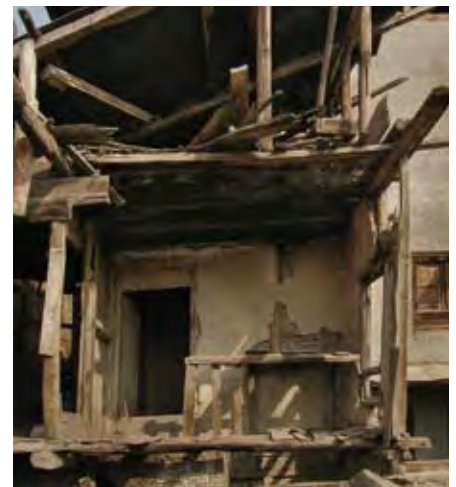
*3.6.1e This is a section view of the house, the oblique view of which is shown in Figure 1.2d. This view provides the unique opportunity to see the entire dhajji structural system at its most basic pre-industrial level. Few of the timbers have been sawn or shaped, and many are thus curved to the shape of the trees from which they came. The floor joists, which run from left to right, can be seen where they penetrate the exterior façade on the right between the top plate of the frame from the floor below and the bottom plate of the frame of the floor above.*

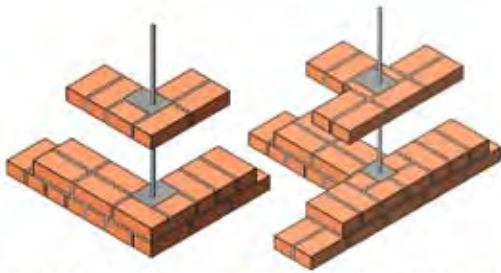
Fig.11.6: Recommended joint details with the vertical reinforcement at corner of brick masonry walls

**5.B: VERTICAL REINFORCEMENT: Concerns about vertical reinforcement shown in NBC 202 and 203:** One provision in each of these NBC codes which concerns me is the requirement for vertical reinforcements in the corners of the buildings and at other wall intersections for several reasons: (1) they are hard to execute during the construction process in a way that will not rapidly deteriorate – that is to rot, if they are timbers or bamboo poles or rust if they are steel reinforcing rods, and (2) they will be incompatible with the load-bearing masonry walls which must be allowed to settle and shift naturally without the transfer of loads to vertical structural members embedded in the walls such that their full overburden weight is partially removed from the wall, and (3) it will fail to work as intended in the event of future design level or greater earthquake by causing disruption to the surrounding masonry in mud mortar during the earthquake. This third point is based on empirical observations of earthquake damage in Turkey to buildings that had vertical elements in otherwise unreinforced rubble stone masonry walls where the stones fell away revealing the embedded timbers and remained intact on either side.

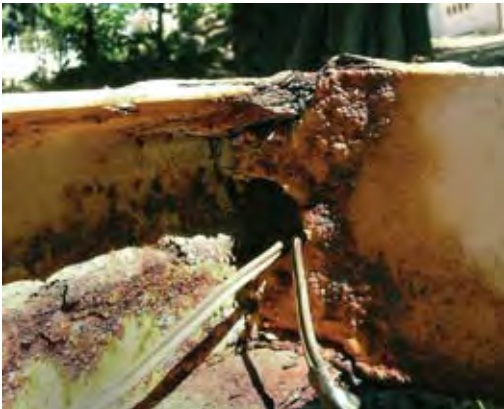
3.6.2b This example of rusting steel demonstrates the expansion that occurs when the iron converts to an iron oxide (rust). The force of this on surrounding materials is sufficient to break any masonry or concrete cover.

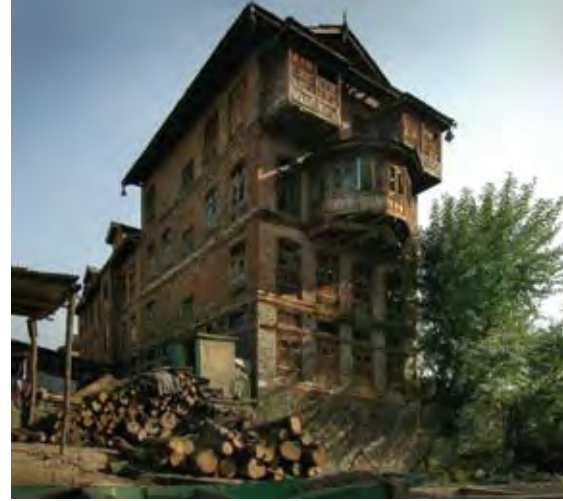
*3.6.3a A once splendid five-storey house of taq construction along side the Rainawari canal, Srinagar. These large houses in the Rainawari area are constructed on the very soft soils of what was once the middle of Dal Lake. The timber lacing is essential to their stability, and their age and durability demonstrates that multi-storey buildings of masonry and timber can be safely built.*

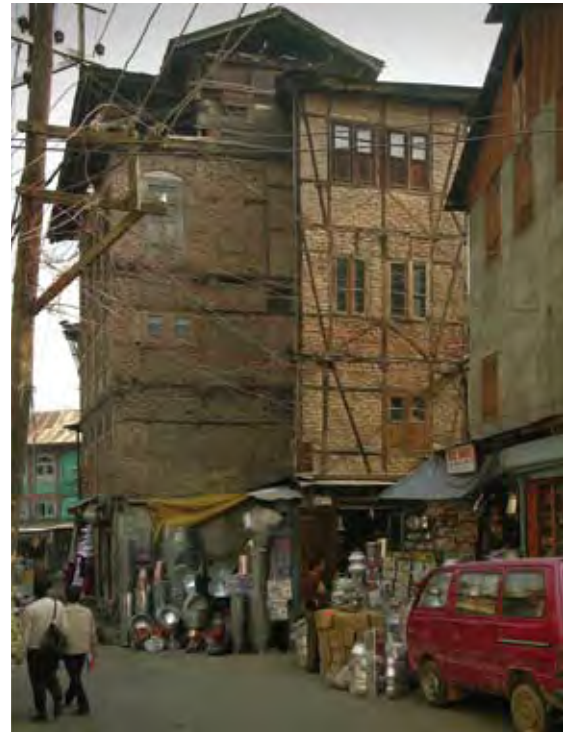
*3.6.3b A five-storey (including attic level) taq building and four-storey dhajji dewari building in the commercial centre of Srinagar. These and many others in Srinagar may be reminiscent of the kinds of buildings which astonished Kalhana in 1148, Tímúr in 1398 and Dughlat in 1540.*

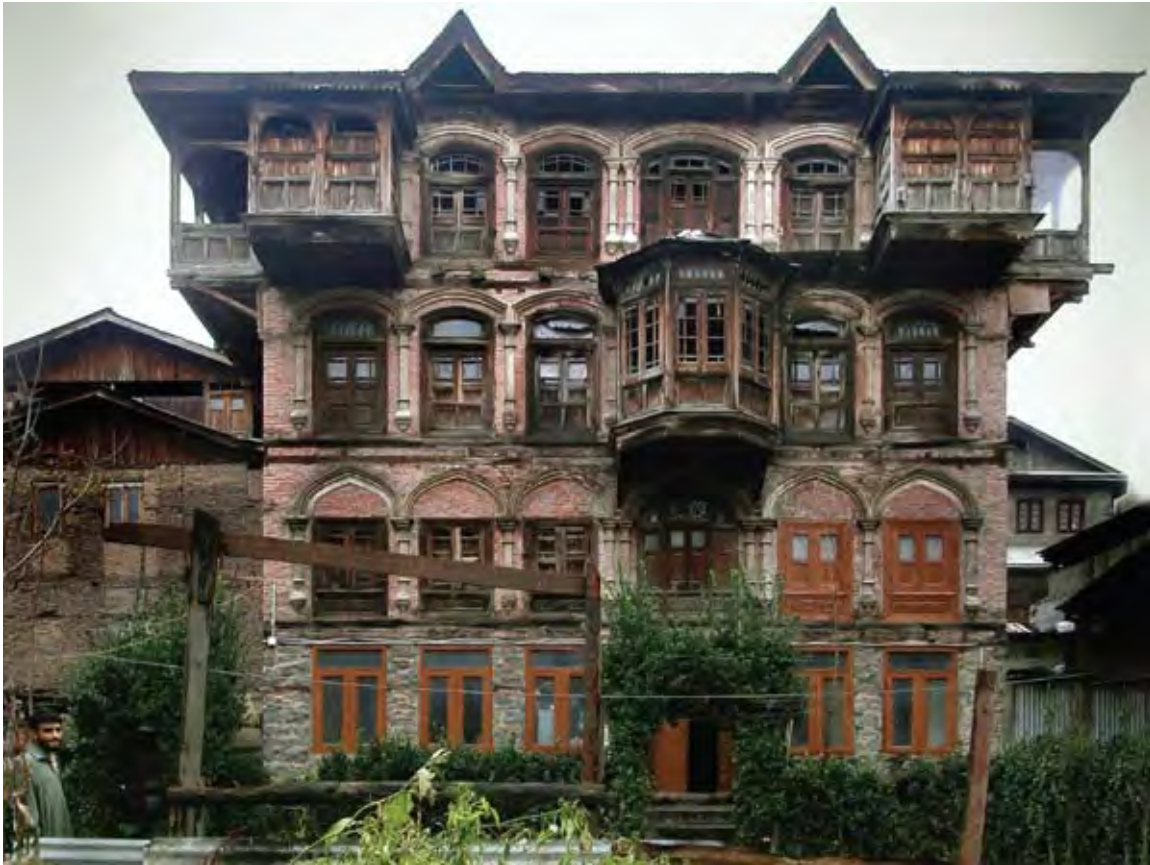
3.6.3c *The Gargoo Residence in Bulbul Lankar, Ali Kadal, Srinagar. This house is four storeys plus attic in taq construction, with a stone base and brick upper storeys. Photo by Akshay Kaul.*

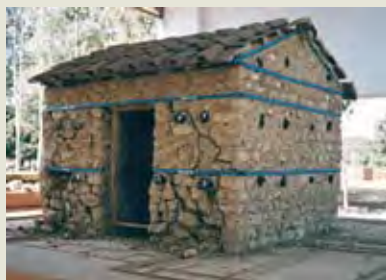
3.3m & n Full-size models of rubble stone low-strength masonry houses, 3.3m with seismic bands, and 3.3n the same construction but without seismic bands. Both were tested on the IIT-Roorkee shock table. Source: Agarwal et al, 2002.

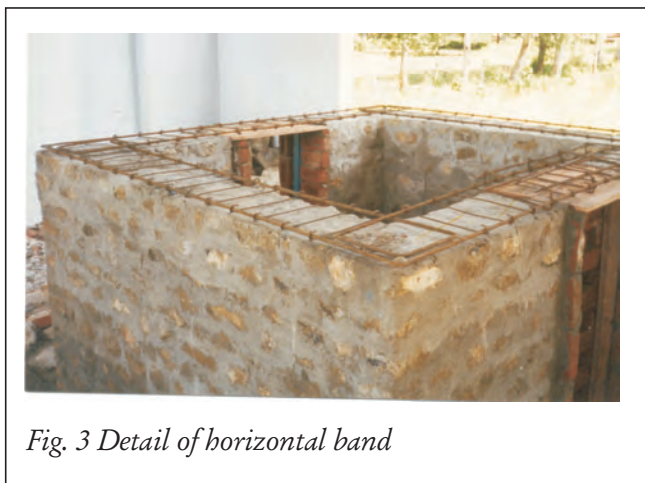
Fig. 3 Detail of horizontal band

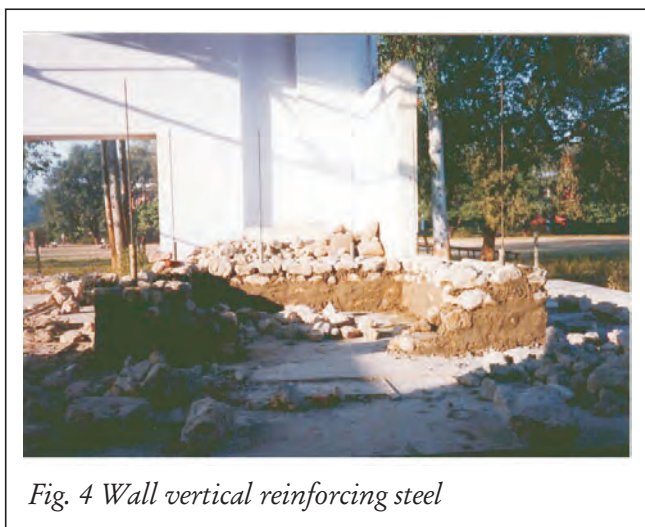
Fig. 4 Wall vertical reinforcing steel

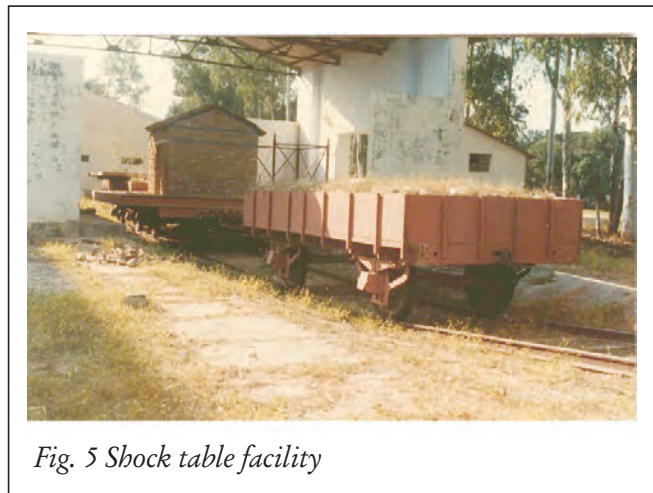
Fig. 5 Shock table facility

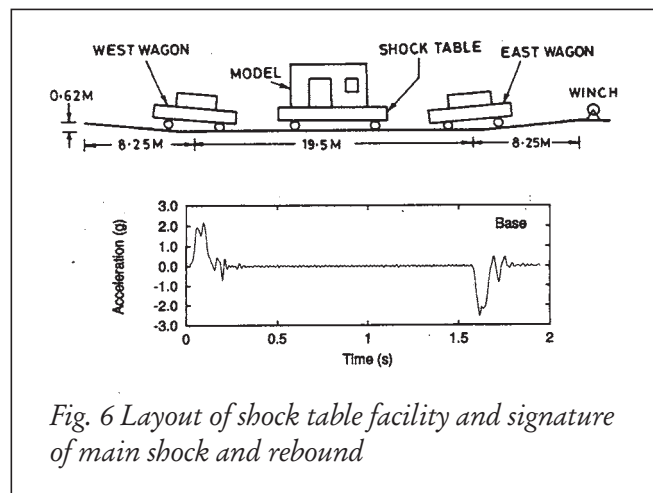
Fig. 6 Layout of shock table facility and signature of main shock and rebound

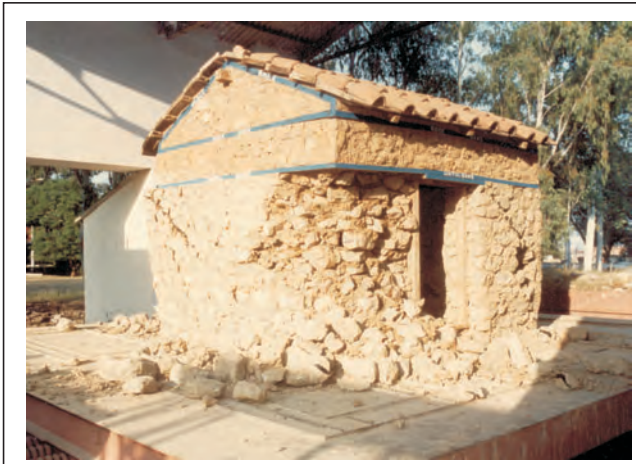
*Fig. 7 Partial collapse below lintel band*

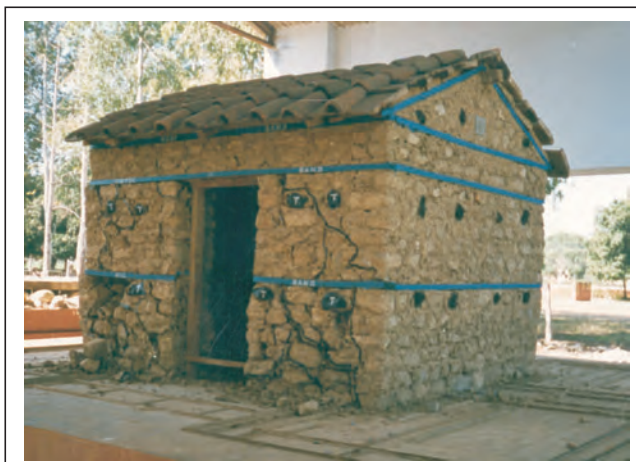
*Fig. 8 Positive action of bands reduces damage sharply*

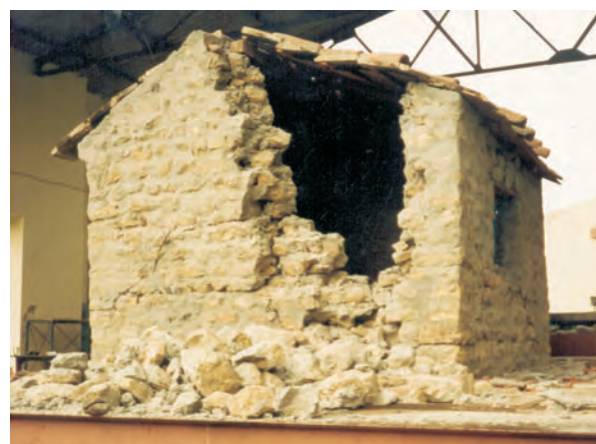
*Fig. 9 Unstrengthened house of cement-sand mortar*

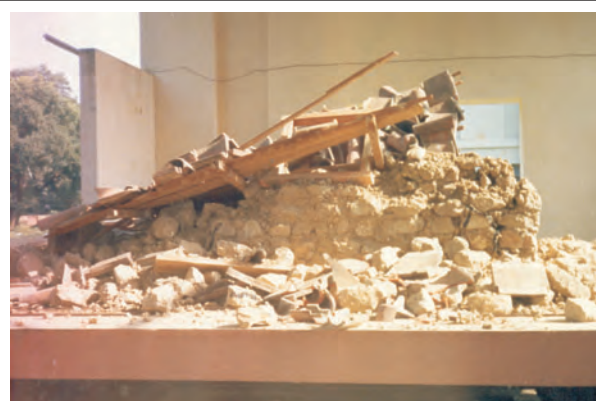
*Fig. 10 Unstrengthened house constructed with mud mortar*

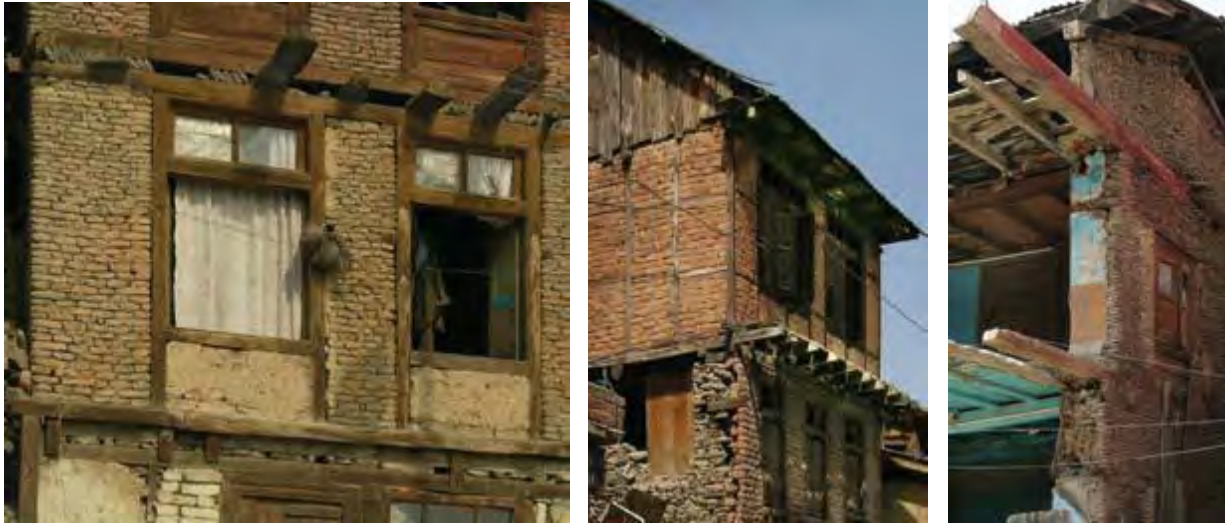
3.6.1 a, b & c Photographs showing construction details of taq buildings. The one on the far left shows the front wall perpendicular to the joists in a taq building, showing how the joists are sandwiched between the timber bands. The second shows how the secure connection of the joists to the front wall bridged the earthquake-collapsed rubble-stone side wall. The third show a taq building partly demolished, exposing the timber lacing in the wall parallel to the joists.
