## Hanuman Dhoka Palace

Photographs by Kai Weise after the earthquake

**My text on this and the following pages is addressed to Kai Weise in Nepal**

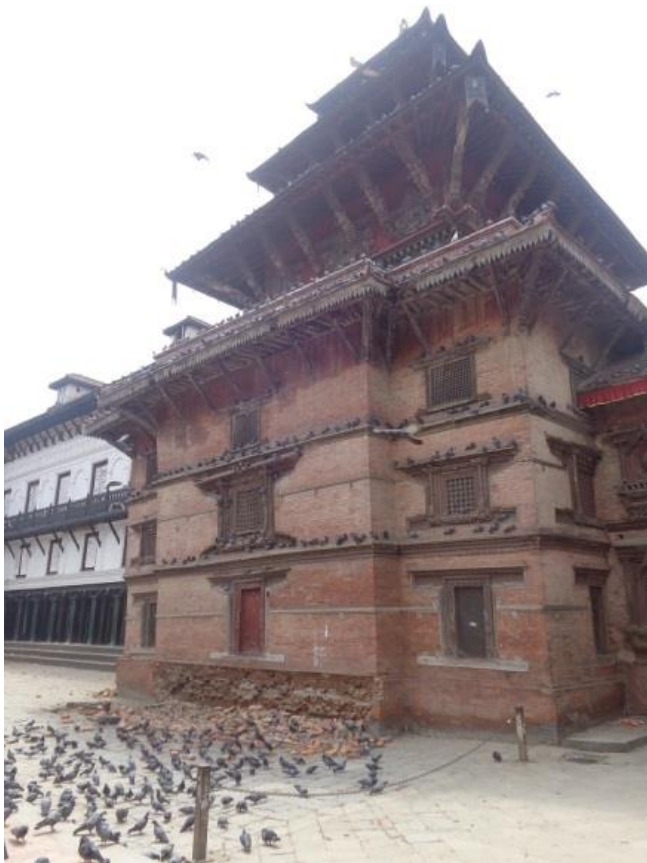
**One Question:** Your photo # 5662 taken on the 26<sup>th</sup> of April (a day after the quake, if the Date and Time setting of your camera is correct) shows the exterior brick wall of the same section of the palace as Photo 6177, taken today, the 10<sup>th</sup> of May. In between, I have seen this same wall published by the New York Times – showing before and after shots (attached between your photos), so I am familiar with it because I had an email conversation with Richard Hughes about exactly that spot.

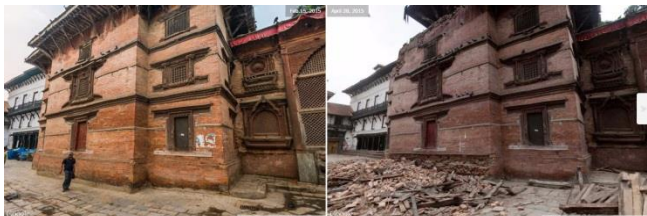
Your earlier shot is striking because it shows, if I am not mistaken, that the lower roof collapsed in an aftershock, after you took the 1st picture! Can you confirm for me that this is the case – and if you know what happened to bring down the roof in what was a much smaller aftershock, than the original earthquake, or were there some large aftershocks?

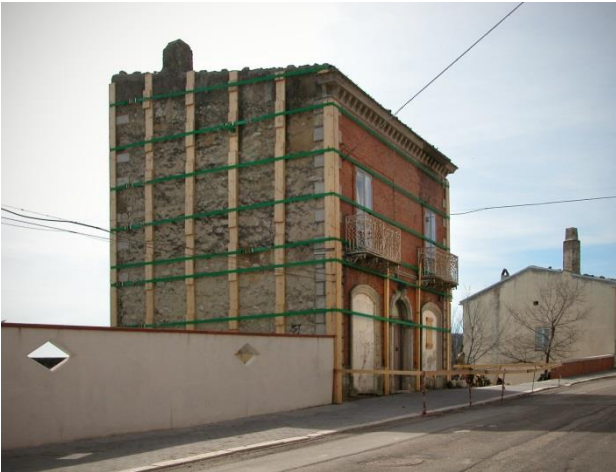
**A perfect solution for shoring** of vulnerable outward leaning walls are used in Italy after earthquakes as seen here – polypropylene straps that can be wrapped and tightened around buildings with outward leaning damaged walls. This is far more efficient and less expensive than external bracing.

Try to get your Italian team to arrange to send these to you, or tell you how to get them.

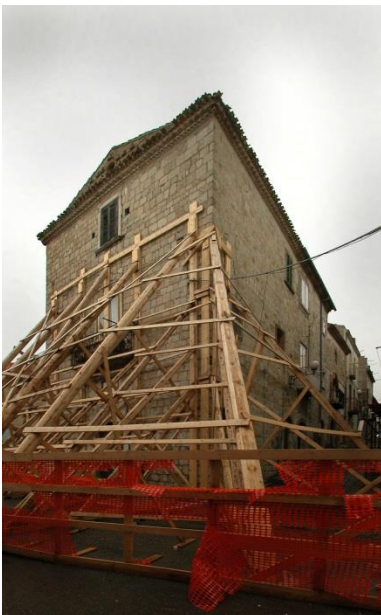
Here (middle row) shows the same way of solving the problem, but with steel cables rather than polypropylene straps.

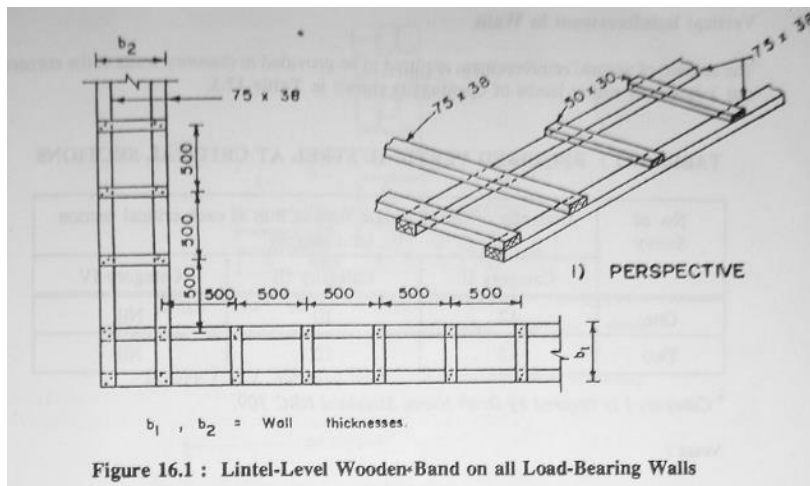
The two interior photos show that the timbers are on the interior surface as well as the exterior surface – thus they are probably configured not unlike those in Kashmir shown the Nepal Building code shown here, except that the cross pieces lie below the timber runners. These are the kinds of timber bands that are described by Dipendra Gautam, whom I am copying in this email.

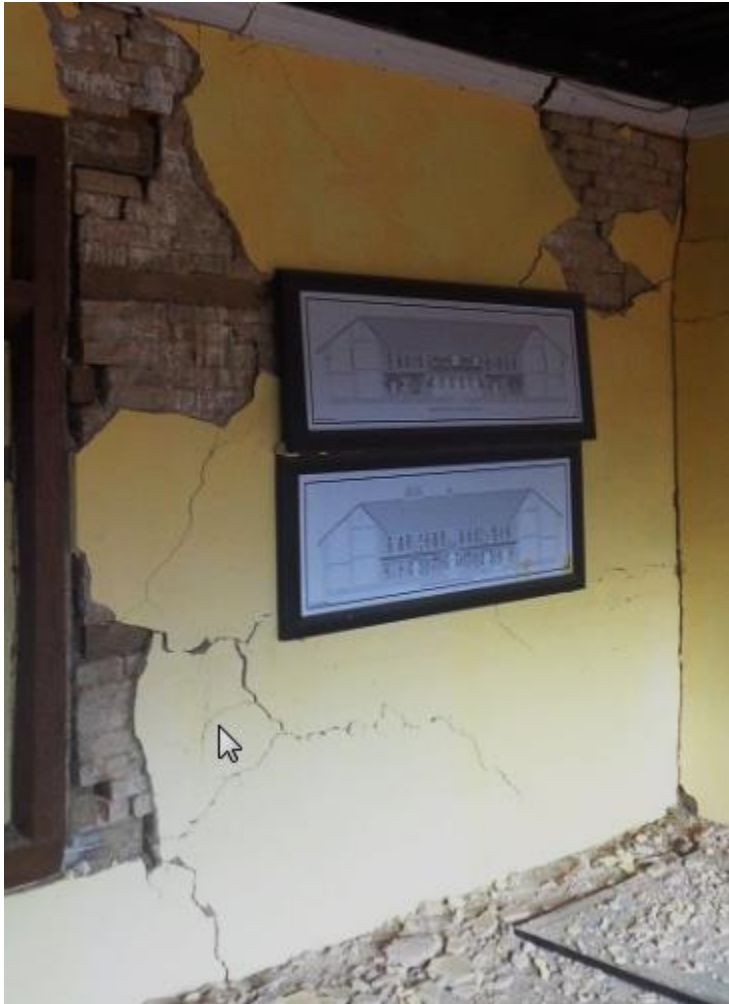
These interior photos on page 5 serve to give evidence of the effectiveness of these timbers in holding the walls together to prevent collapse of the building. Notice how the plaster has fallen off of the wall. It is clear from this that the walls felt the strain from the earthquake shaking.

However, there are cracks visible in the remaining plaster, but they do not form a single large “X” as is characteristic of shear failure of the wall, which is the precursor of collapse. The timber bands on the inside and outside of the wall have served to stop these cracks, and keep the walls from spreading.

In my opinion, from looking at these pictures (without the benefit of being there to look more carefully), these parts of the palace with the timber lacing look quite sound, and not on the verge of collapse, although it suffered the loss of the tops of some of its pagoda towers.

One important survey that I recommend be conducted is to record onto the drawings the locations within the building that have the timber lacing, and inspect it carefully to see its condition. Also, make note of those areas where it does not carry around the whole structure. An important point: the bands at the floor levels are not visible in the photographs, but are of critical importance structurally, as they hold the floor diaphragms to the walls. It would be good to see during the restoration work where they are, and determine if the floor joists extend through the walls, and check to see if there is any decay in the embedded timbers.

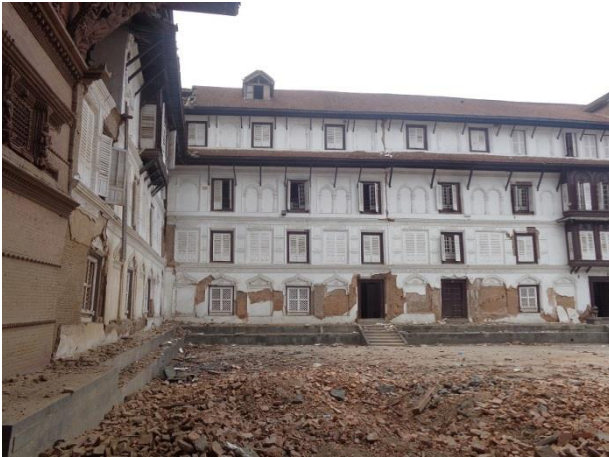
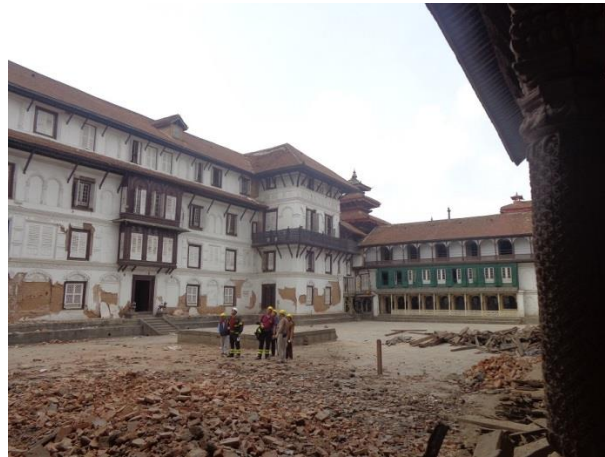
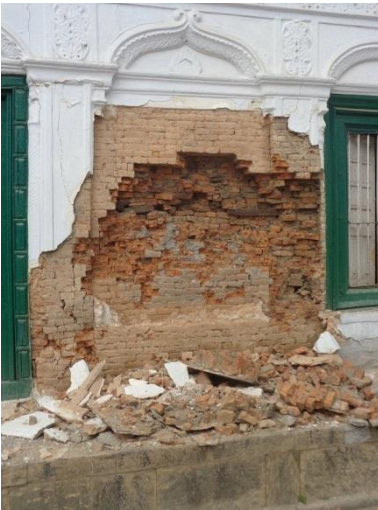
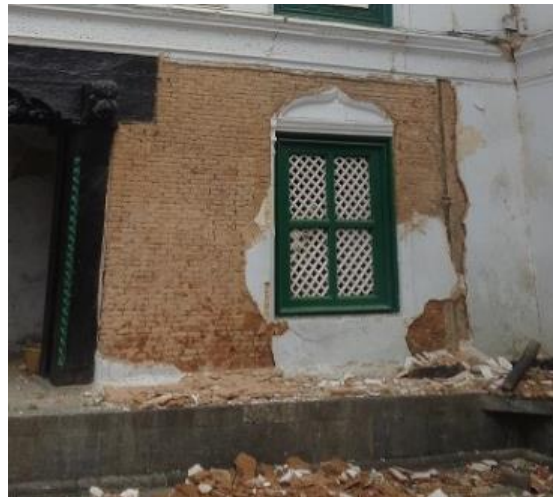
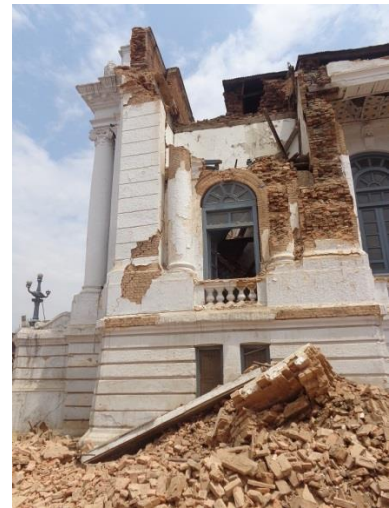
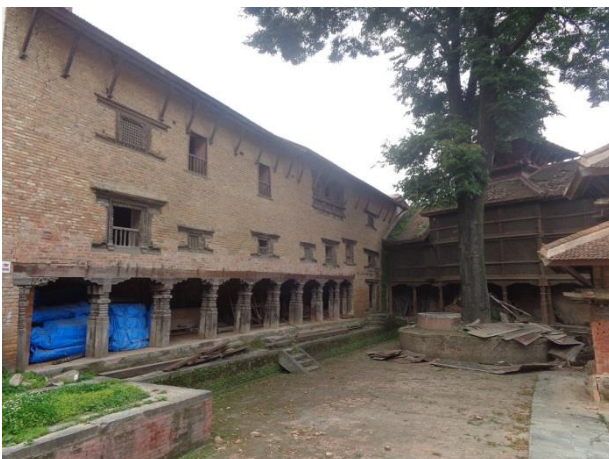
It appears from the exterior that this wing has survived with little or no damage, so it would be good to determine if this is true, and what features of its structure and age may have contributed to this.

It does not appear that the classical revival section and the long white range of the palace, as well as the unpainted brick wing shown here have timber lacing in the walls. In the case of the classical revival wing, shoring is needed, and the strapping technique shown on page 4 may work well for this.

In the case of the long white range, it appears that the most strain was felt at the base of the structure where the plaster surface has fallen off. It appears that the bricks are under-fired, and thus weak, perhaps further weakened by rising damp. The strain may have been from the building rocking back and forth, which compressed the bricks and caused the plaster to shed.

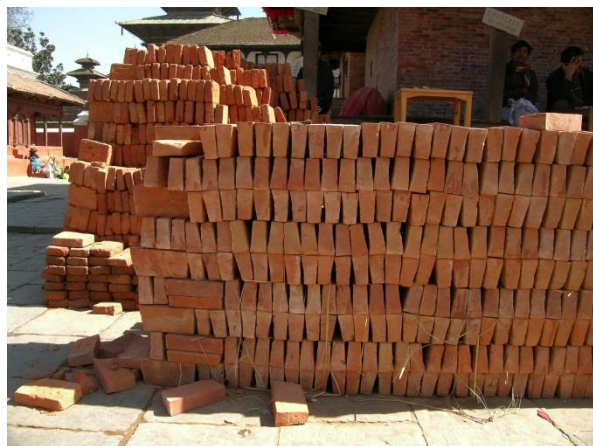
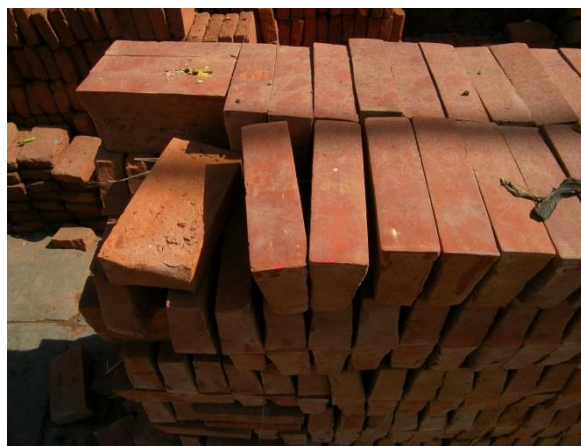
There one particular feature to the traditional construction in Nepal which I wish to address once again – as I had mentioned it in one of my earlier newsgroup emails – is the traditional design of the face bricks. In Nepal, as I have not seen this anywhere else, the specially made face bricks for the more important buildings – temples and palaces – are manufactured with a wedge shape, which allows the mortar bed to be hidden, giving the facades their iconic pencil-thin mortar joints. Kai – perhaps you could help me learn about the history of this, but I have seen it on my trips to Nepal, both at the brick yards, and also at a restoration project of one of the temples next to the **Hanuman Dhoka Palace**, and at the restoration of the **55 Windows Palace**. These are photos I took of them in front of the Hanuman Dhoka Palace in 2005.

While this is both unique, and contributes to the architectural distinction of the Kathmandu buildings, I wish to point out a concern that I have about it from a conservation and earthquake hazard perspective that I have not yet seen discussed. As buildings age, the mortar – particular mud or mud/lime mortars, tend to erode and dry out and deteriorate in the walls. With ordinary rectangular bricks, the structure of the wall may weaken, but the position of the bricks does not change, nor their ability to carry the loads. With the wedge-shaped bricks, a loss of mortar can cause the bricks to rotate slightly, such that their fronts are no longer truly vertical. In ordinary circumstances, this may not be noticed, but as the compressive strength of the mortar weakens, and an earthquake comes, the added force can suddenly cause the face brick layer to pull away from the core of the wall. The shape of the bricks combined with the infrequency of having true bond courses, thus may account for some of the areas of delamination that we see.

It may be worth studying this feature in detail by surveying earthquake damage to try to recognize where this brick shape may have played a role in the damage. When rebuilding the walls, it may be worth considering the addition of a thin wedge or pencil-sized piece of fired ceramic into the mortar joints towards the rear of the bricks so that the vertical compression on the wall would not bear unevenly onto the facebricks. This is just an idea that will need further investigation, but I suggest a solution so that one can see a way to fix the problem without changing the traditional architecture if it can be determined to be a contributing cause of damage to the buildings.

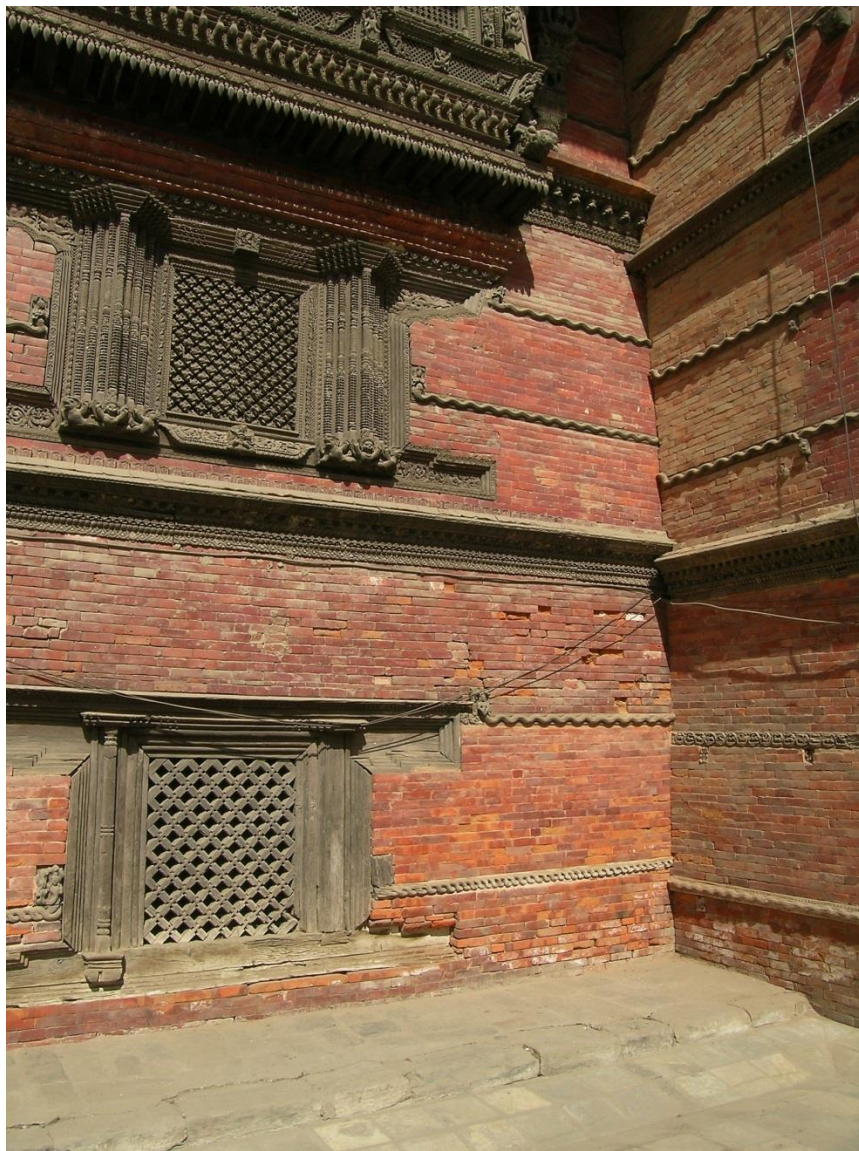
This is a photo I took of the walls of the Hanuman Dhoka Palace in 2005. It is possible to see some crude repairs which may be where bricks fell out of the wall. Also, some have lost their front surface from spalling, and there is evidence of salt attack at the base from rising damp – which also serves to weaken the bricks. It is possible that the string courses visible on the wall are tiles which cover timber bands, so I will be pleased to know if this is true here.

**In conclusion**, there is much further study needed to know how best to restore the walls of the palace, and determine where it needs to be strengthened. It may be possible to grout the walls to consolidate them, but that will require serious on-site consulting. The one important caveat is to avoid any grouting with Portland cement as it would be highly destructive to the historic fabric in walls that appear to have survived the earthquake remarkably well.

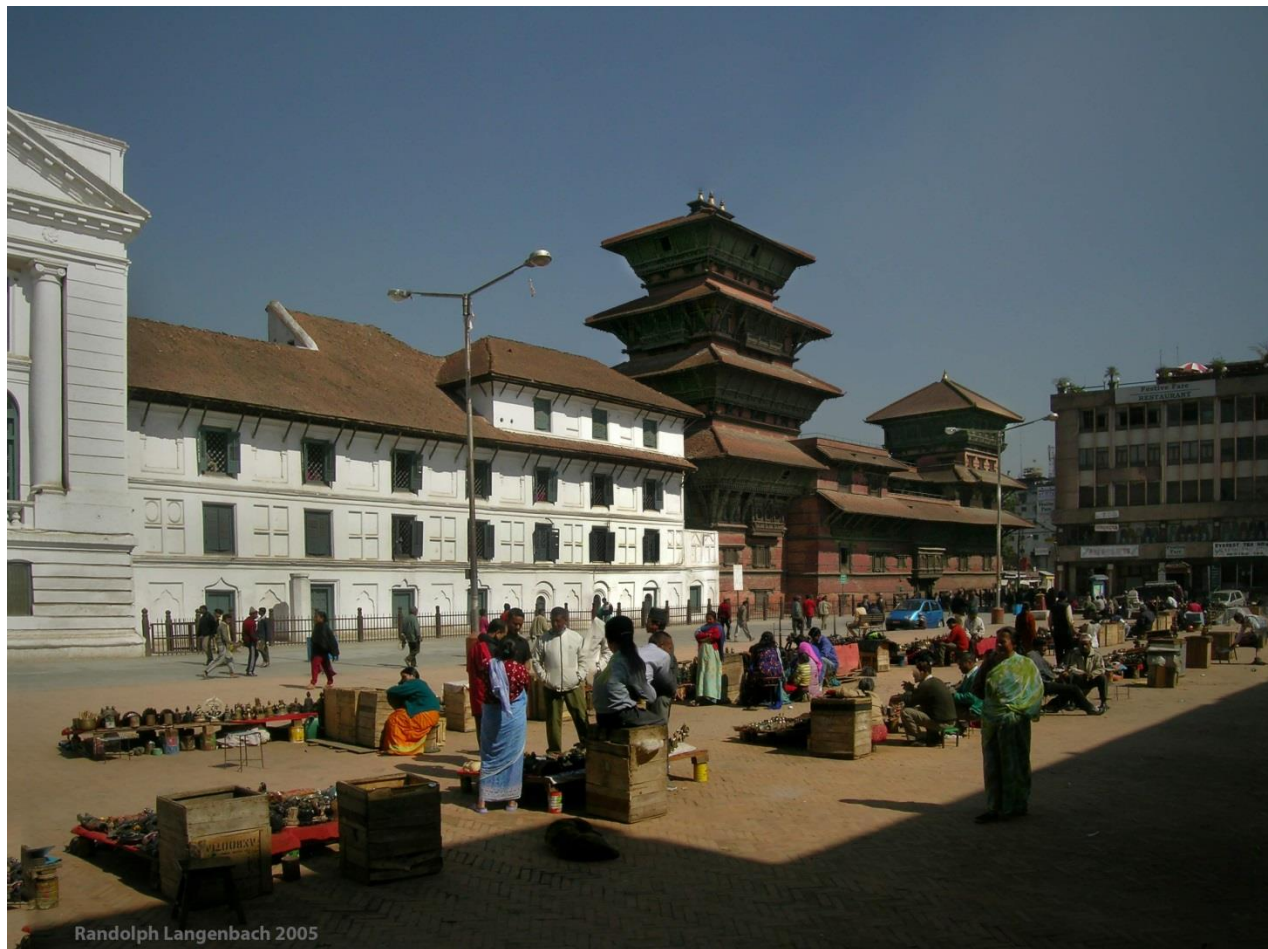
**This is a photograph from my collection of 160 photographs just of the Hanuman Dhoka Palace taken in 2005.**
