THE GORKHA EARTHQUAKE IN KATHMANDU VALLEY

Post-earthquake correspondance to and from Randolph Langenbach

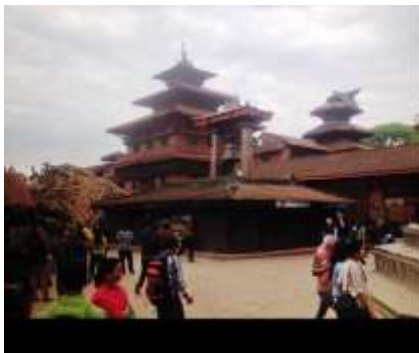
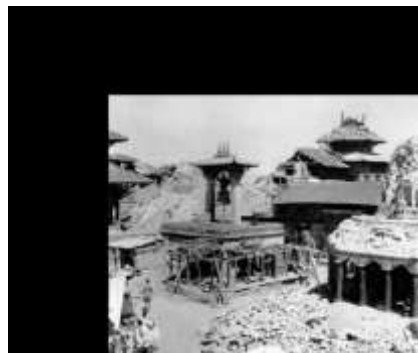
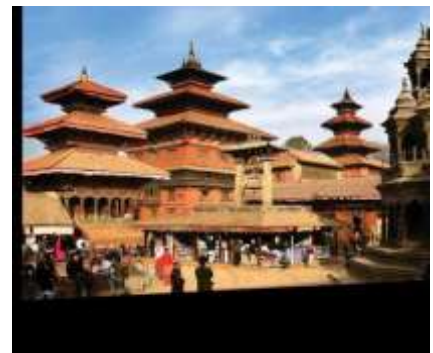
In sorting through all of the data that is flooding the web following this tragic earthquake, I have begun to see some patterns that are interesting. This is just a glimpse, but here are three images mined from the web, which I have overlaid and printed to a similar scale so that one can see that they are of similar views. They reveal that the buildings that collapsed in 1934 are still standing after the recent quake, but the temple that appears only slightly on the left, while in 1934 it is clearly still standing as its roofs show in the 1934 shot, but it is pancaked in the recent quake as can be seen in #3.

Overall, it is beginning to appear that the frequency of the shaking in the two earthquakes may have been different, as the epicenters I understand were in different locations, and Kathmandu itself, being remote from the epicenters of both, has suffered from a soft soil response to the earthquake vibrations, which then singles out structures that have the same vibrations as the soil – similar to what happened in San Francisco and Oakland in the Loma Prieta earthquake (I barely felt the earthquake while the freeway on fill in Oakland, and buildings on fill in SF collapsed.) If our colleagues on site can see patterns like this, it will be helpful.

The example above can also, of course, be a result of the likelihood that the reconstructed buildings were improved when rebuilt, while the temples that fell are now 80 years older than they were in 1934, and perhaps not strengthened or well maintained.

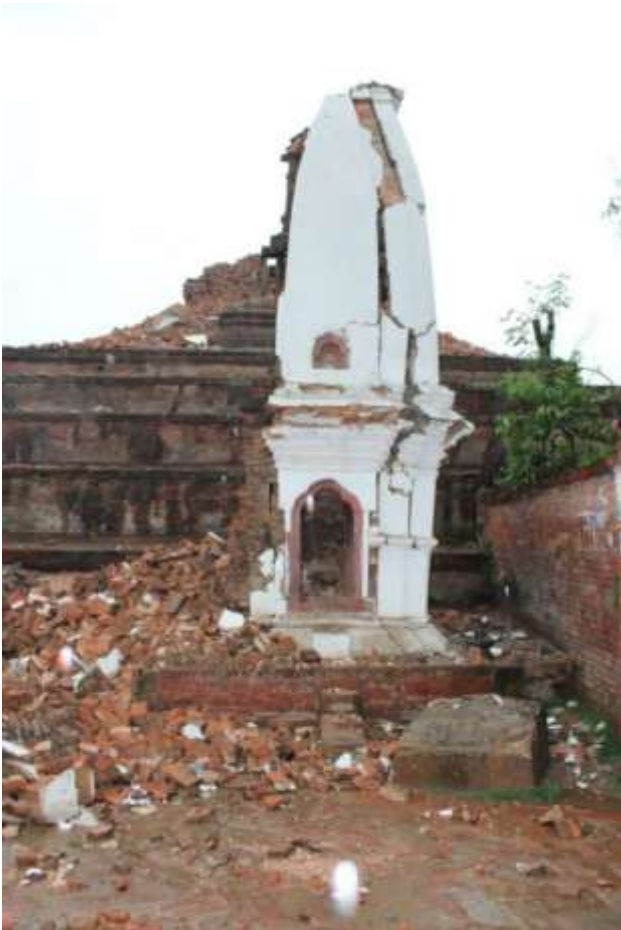
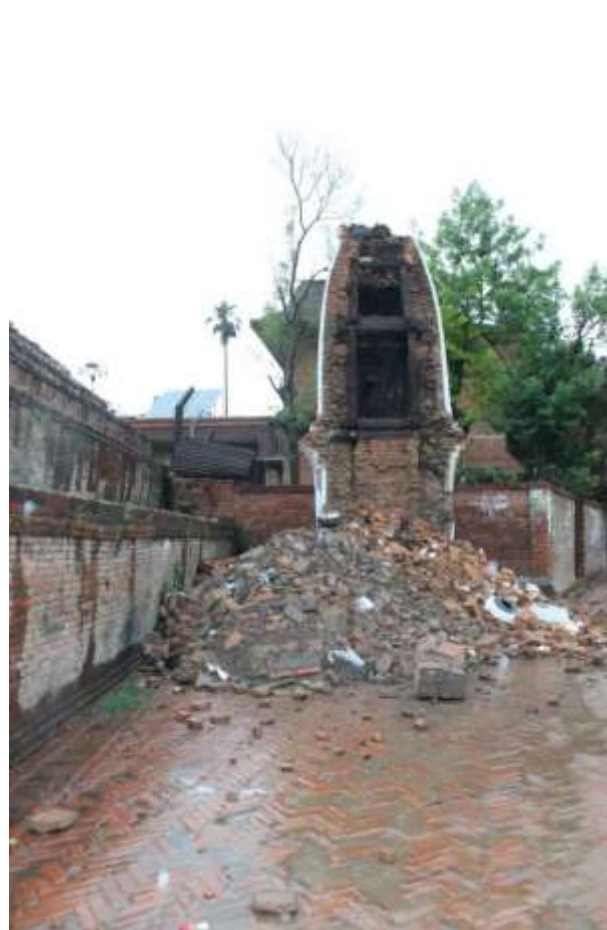
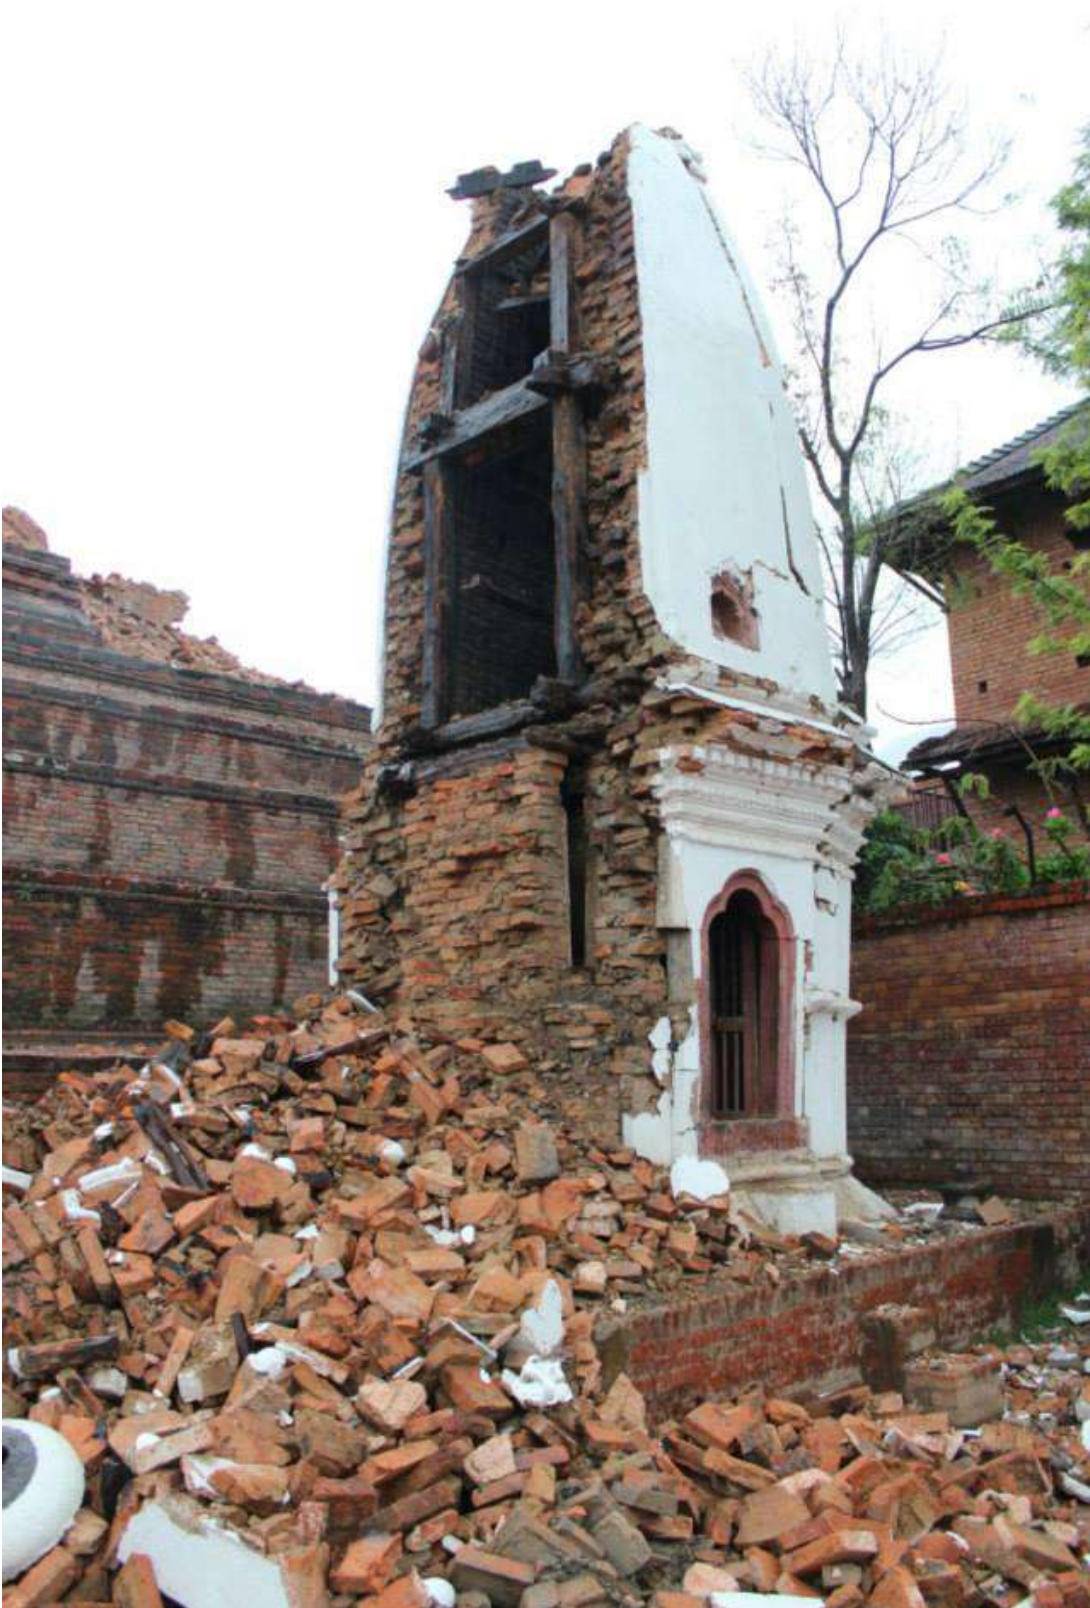
Through visiting the photos which have been demonstrated by Neelam Prdhananga, I have noticed three photos grabbed my attention, which are:[below]

.....and we can see from the above photos that the cultural heritage has been divided into two sides of the center. We can see the left side has been completely destroyed and collapsed while the right side dismantled, but still connect in somehow in the original structure. Also, we can see most of the wood of the architecture still connected in good shape slightly. I hope we can discuss this situation if you don't mind.

This damage in my opinion is the result of having a timber framework inside hard against the walls of a bearing masonry structure, but not extending into the structure as it would if it were timber laced masonry. Whenever I have seen this, the problem is that the masonry in effect is not allowed to fully bear onto itself below, as the load path is shared by the frame. The frame is flexible (note that it is not braced) so in the earthquake, the masonry weight responds to the vibration of the earthquake, but the frame then allows the top layers of the structure to sway – which cause the side walls in the direction of the sway to separate, as they have only the short (and rotted) ends of the timbers extending into them. In fact, the structural damage may tell us roughly what the primary wave direction is at this location.

On the other hand, since there seems to be a pattern of tall structures on narrow bases having collapsed in this earthquake, I suspect that they were collapsed often by rocking back and forth, causing compression as well as shear failure of the momentary overloaded masonry on the corners and walls at the base, as shown in the onset of damage in a photo circulated by Kai Weise (ICORP) below. This then narrows the base further, and the structures begin to tip over, which then at a certain angle, they pancake the rest of the way in place. This goes part of the way to explain why the pagoda temples which have graced the durbar squares for centuries have been particularly hard hit – and can be seen to have EITHER fallen down completely, or remain standing quite intact (with cracks we cannot yet see in photos, except for this one by Kai) – rather than as is often with masonry buildings, being damaged partly by the loss of parts of the upper walls or roofs.

Referring to your analysis about the flexibility of the frame related to the solid structure, I agree with you and it is good analysis, but what I was wondering about is why the right side of the monument still slightly connected to the structure while the left of the monument completely collapsed. Also, I agree with you about your analysis that the damage can tell the wave direction especially in this monument.

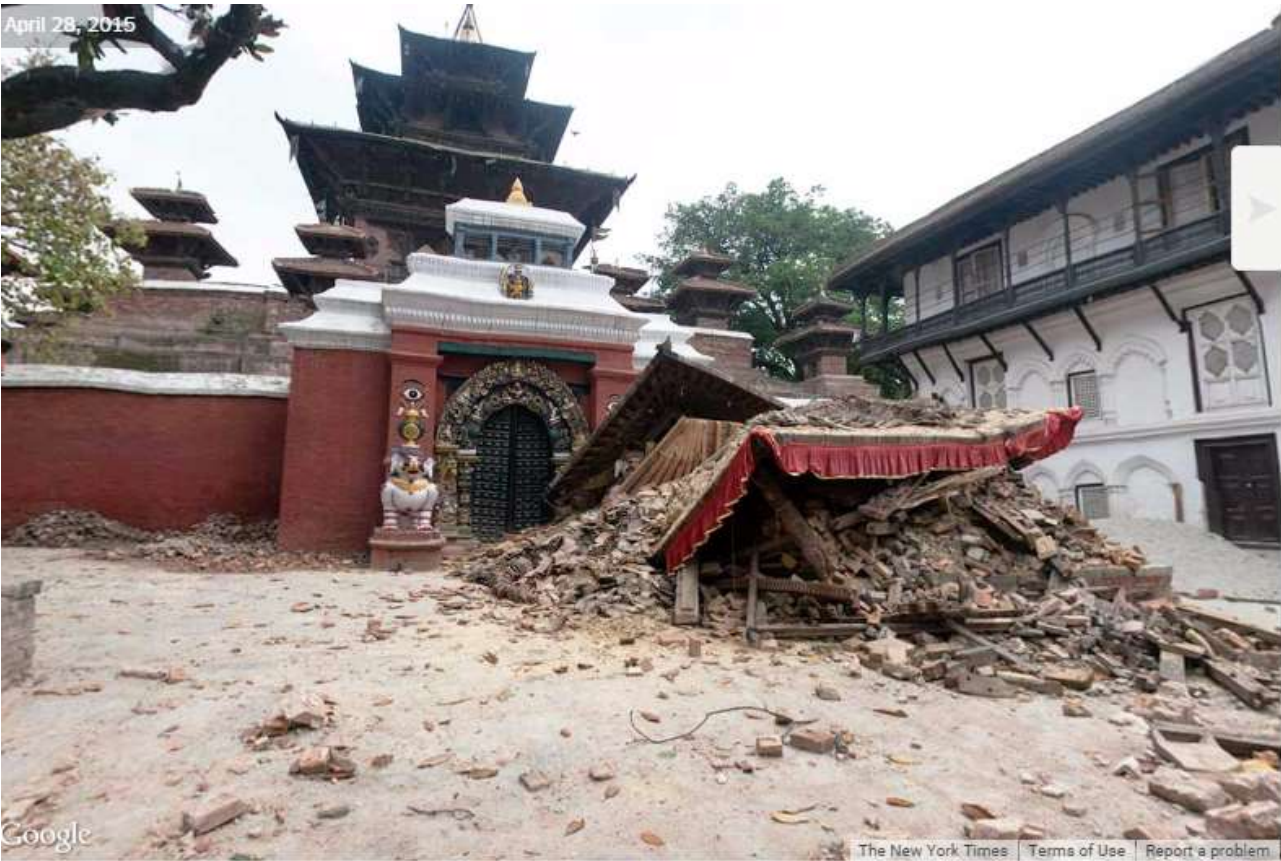
On the question of the difference between the 1934 earthquake and this one, I went looking for a map of their locations, and up popped up first was the map attached here. How uncanny it is that on this map is the clearest prediction of the earthquake that just happened – with its damage district marked almost exactly. Also, the closer proximity of the 1934 quake is an indication that the frequency of its vibrations would have been different in Kathmandu, than in the 2015 quake, which can partially explain differences in buildings that proved to be most vulnerable.

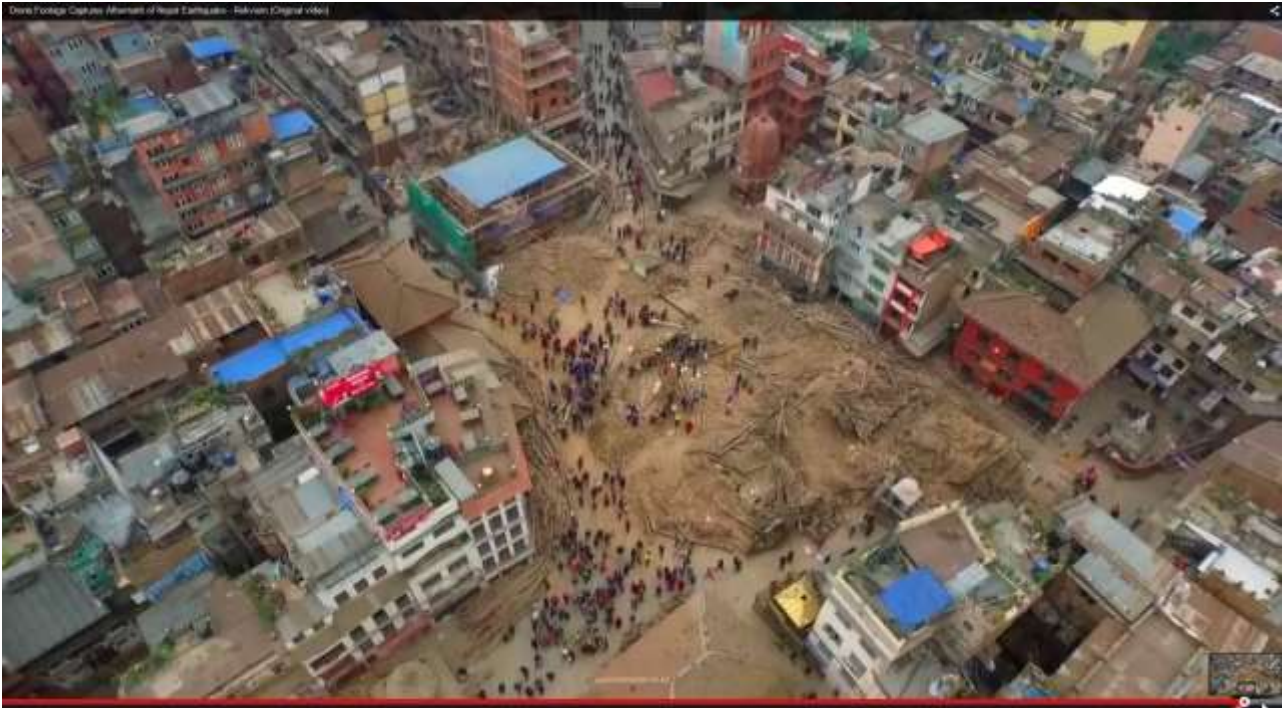
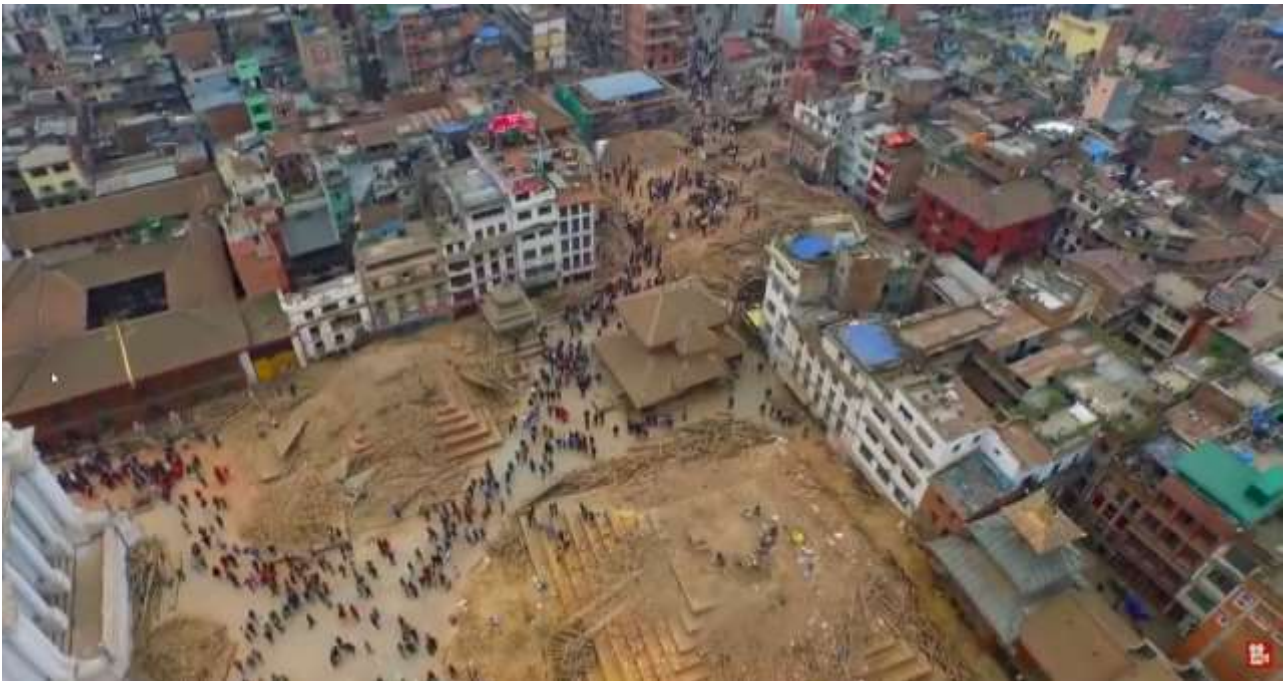
Basantapur Durbar Sq - Drone footage by Kishnor Rana that has now circulated widely on the web. The Red brick building and the small shrine that are visible in your image are also visible in the attached image #2, and #1 one shows the columned building that is the most distinctive monument in Basantapur Durbar Sq., with the side square in the center rear of the image – with the red brick building visible.

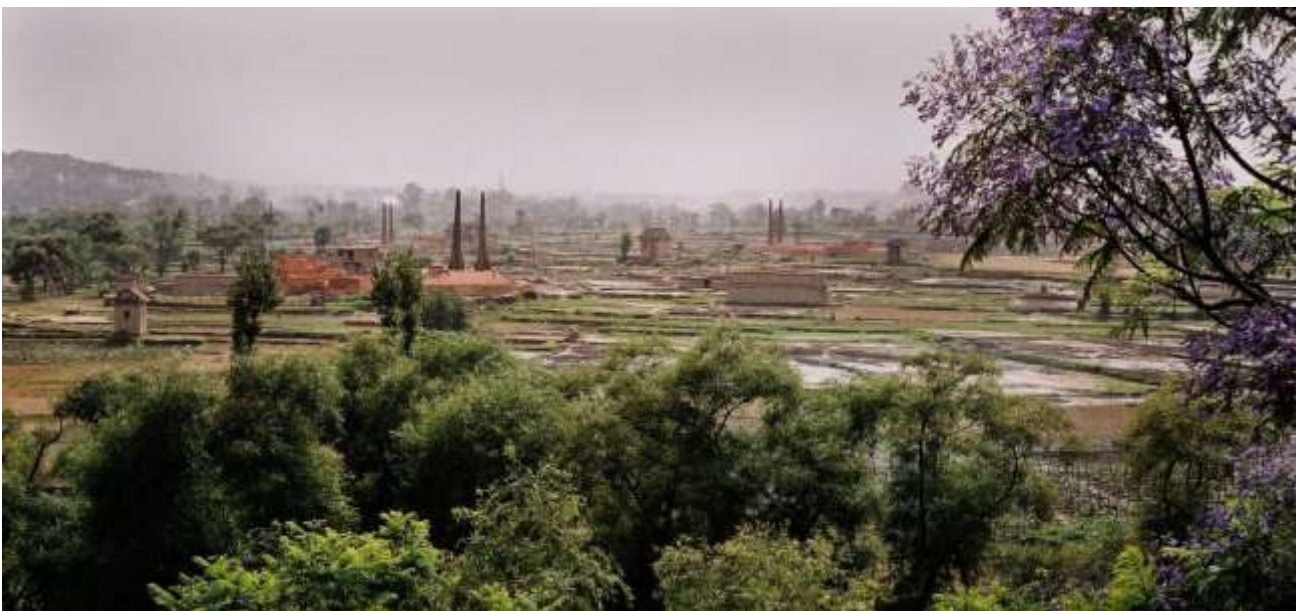
Photos here and below by R.L in 2000

This point though raises another one that is even more likely – the deterioration of the bricks themselves. In pictures posted by Neelam Pardhananga which I have attached here, one can see the typical damage from rising damp in the walls, as well as evidence of differential settlement damage. In observing the web photos of the collapsed buildings, I have seen quite a few broken bricks, and in addition, I am suspicious that a good deal of the dust and small particles are pulverized bricks, not just remains of clay mortar.

The brick industry in Nepal is extremely interesting – and a walk back in time. It is an active tradition that is part industrial, and a larger part pre-industrial. I have attached a view of the landscape of brick kilns near Kathmandu which I took in 2000. The other attached images show the bricks. On average, the bricks are under-fired according to modern standards. Consistent with traditional practice everywhere before the invention of tunnel kilns and uniformly fired brick, the under burns are used for the interior of the walls. The pale red color of the bricks is consistent with the color of what would be considered to be weaker bricks when compared with fully fired bricks today.

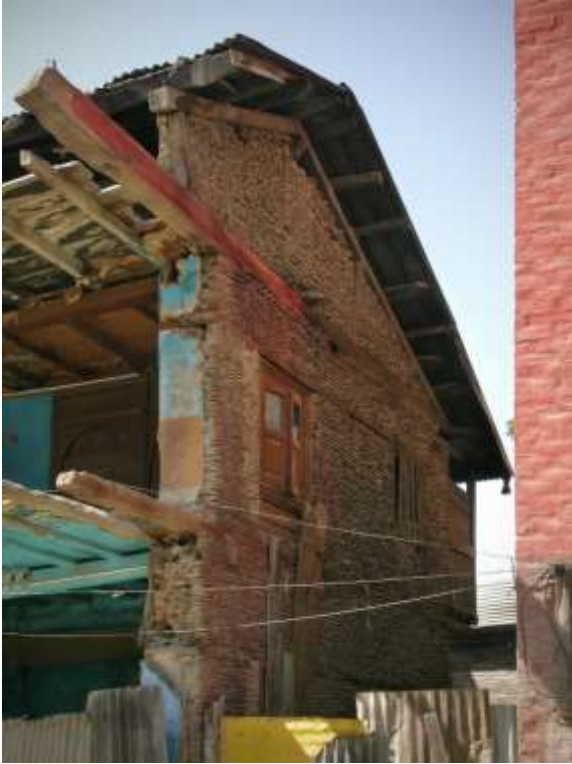
Srinagar, Kashmir, © Randolph Langenbach

The second image (SRNGR'07(27)3-05-RT2) shows the “ladder shaped” timber ring beams extending out from the wall of a building being cut in half by a road widening project. You can see the floor level timbers, and also timber lacing above the windows. These examples contrast with Nepal which lacks them, and their absence leaves the masonry vulnerable to the kind of spreading that you see in the photo by Kai Weise and the damage you see in the third photo attached ('00Nepal-#04-01-RT copy) – which shows damage caused from settlement without an earthquake.

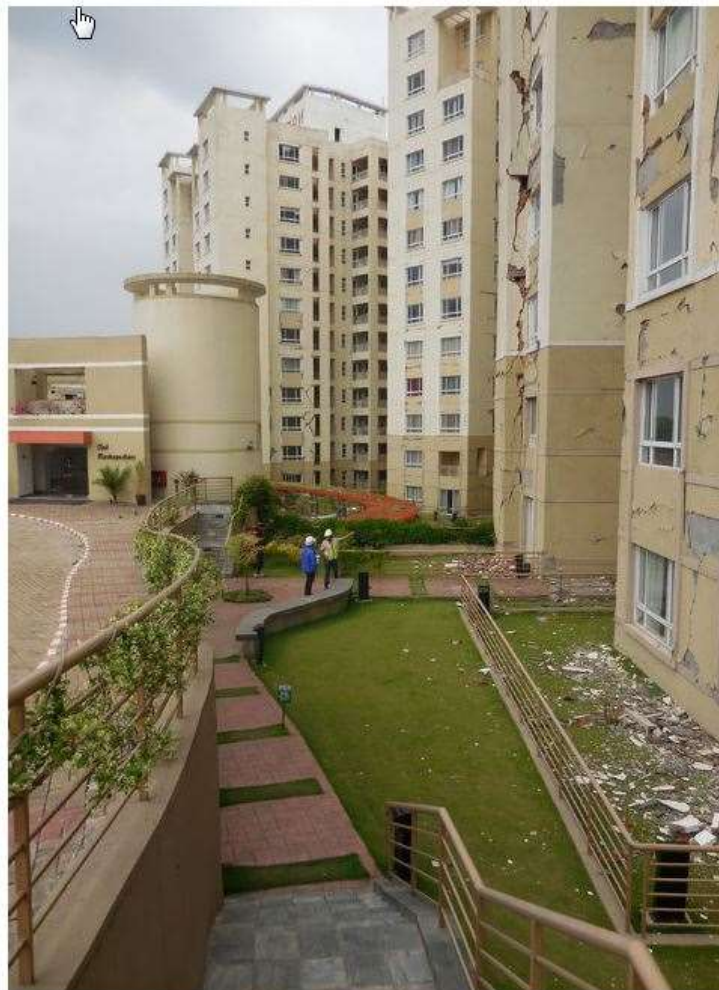
Engineers inspected a high-rise residential complex in Katmandu, Nepal, that was badly damaged in the April 25, 2015, earthquake but did not collapse. Miyamoto International

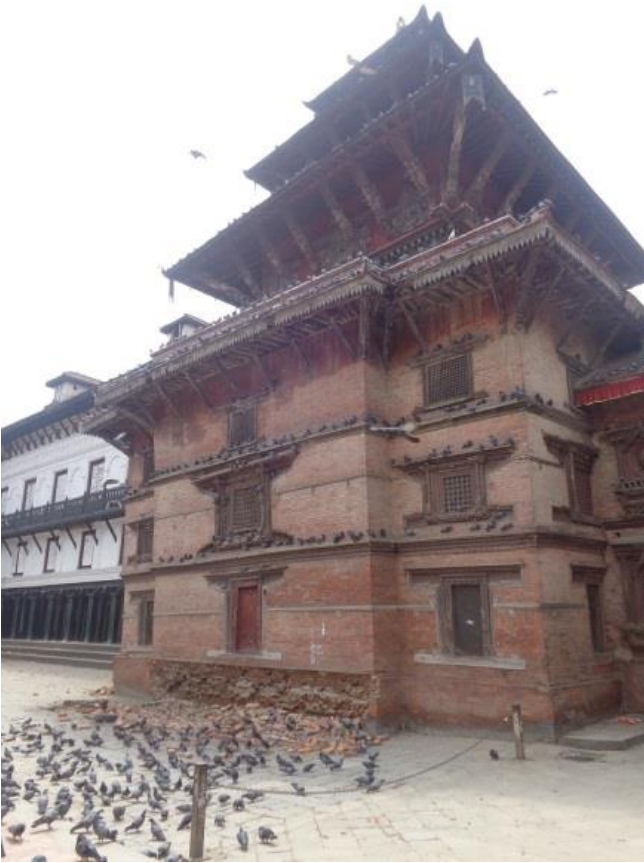
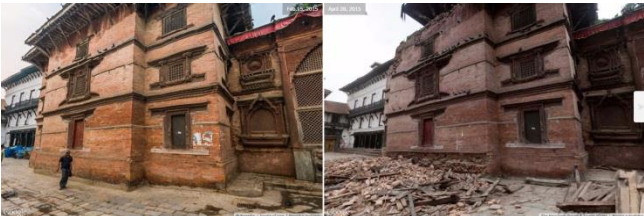
One Question: Your photo # 5662 taken on the 26th of April (a day after the quake, if the Date and Time setting of your camera is correct) shows the exterior brick wall of the same section of the palace as Photo 6177, taken today, the 10th of May. In between, I have seen this same wall published by the New York Times – showing before and after shots (attached between your photos), so I am familiar with it because I had an email conversation with Richard Hughes about exactly that spot.

Your earlier shot is striking because it shows, if I am not mistaken, that the lower roof collapsed in an aftershock, after you took the 1st picture! Can you confirm for me that this is the case – and if you know what happened to bring down the roof in what was a much smaller aftershock, than the original earthquake, or were there some large aftershocks?

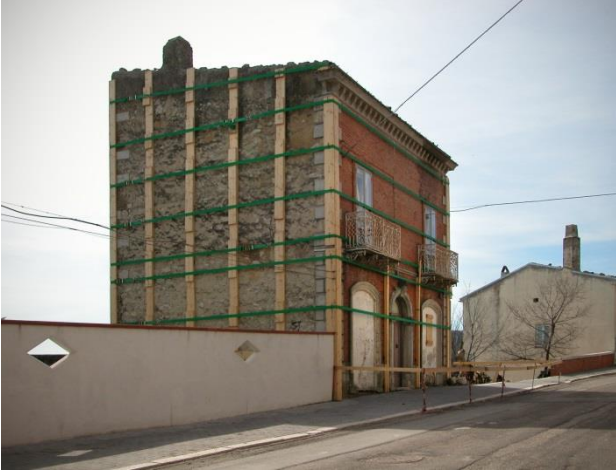
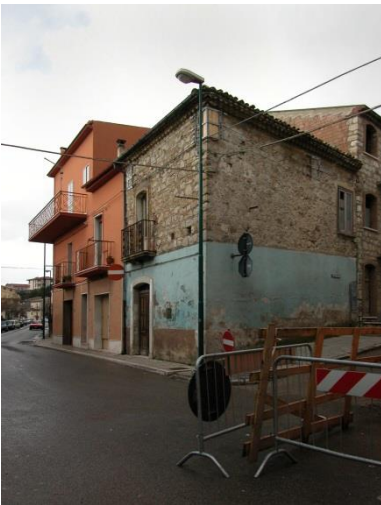
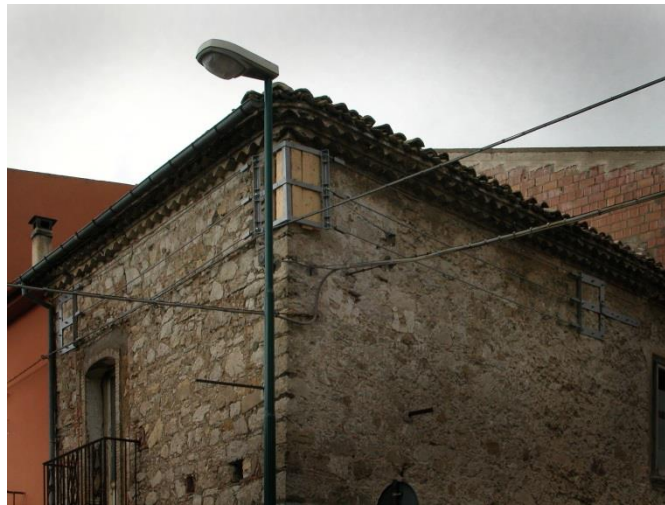
A perfect solution for shoring of vulnerable outward leaning walls are used in Italy after earthquakes as seen here – polypropylene straps that can be wrapped and tightened around buildings with outward leaning damaged walls. This is far more efficient and less expensive than external bracing.

Here (middle row) shows the same way of solving the problem, but with steel cables rather than polypropylene straps.

Bottom: The Italians are masters at the design and engineering of shoring. Here is an example of external shoring in timber.

Try to get your Italian team to arrange to send these to you, or tell you how to get them.

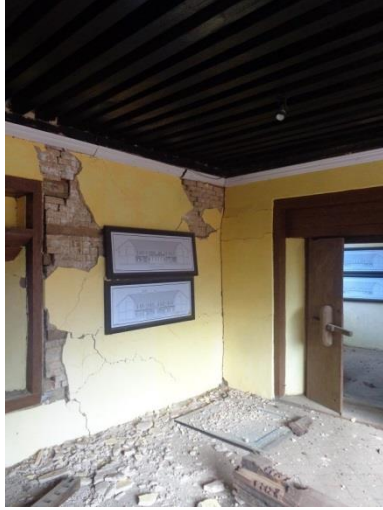
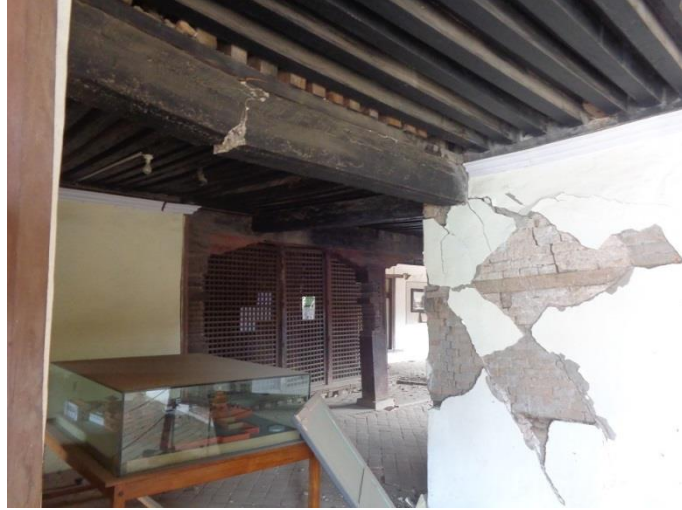
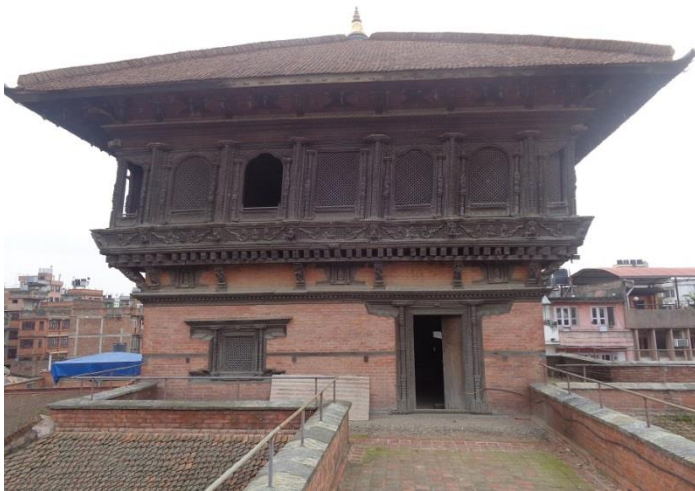
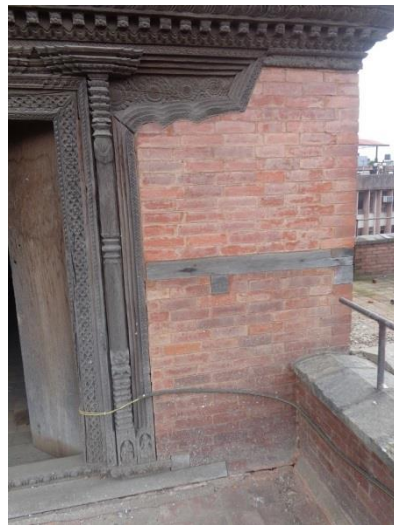
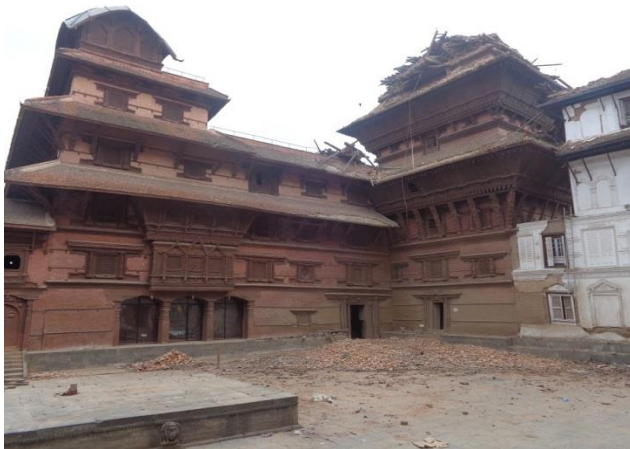
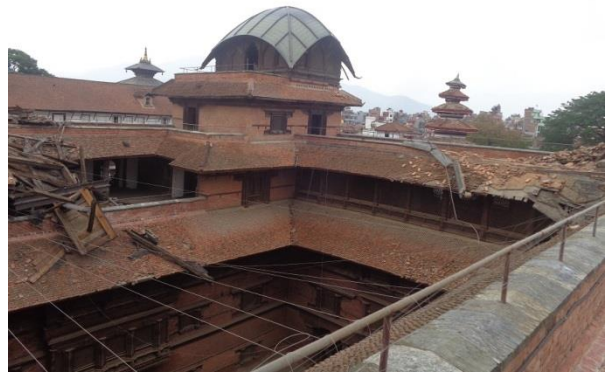
Hanuman Dhoka Palace

On page 5 I have pasted your photos that appear to show timber lacing in the walls of parts of the Palace. From your photographs, it looks like parts of the palace, but not all of it, had timber bands. It seems clear that the later classical revival parts of the structure, and also the long whitewashed range, do not have timber lacing. It also looks like that in some places – as can be seen in the last photo pasted on page 5, that the timber bands may not always wrap around the structure as can be seen here:

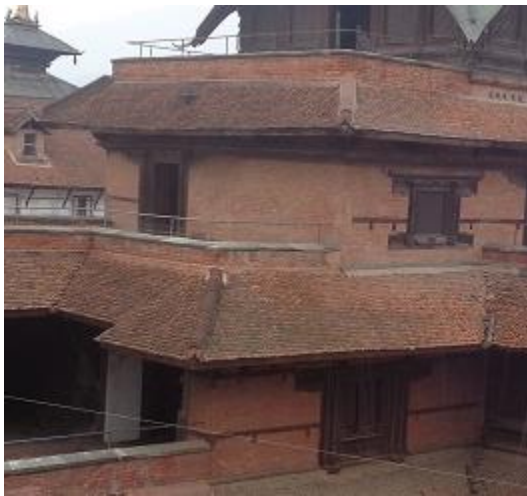
The two interior photos show that the timbers are on the interior surface as well as the exterior surface – thus they are probably configured not unlike those in Kashmir shown the Nepal Building code shown here, except that the cross pieces lie below the timber runners. These are the kinds of timber bands that are described by Dipendra Gautam, whom I am copying in this email.

These interior photos on page 5 serve to give evidence of the effectiveness of these timbers in holding the walls together to prevent collapse of the building. Notice how the plaster has fallen off of the wall. It is clear from this that the walls felt the strain from the earthquake shaking.

However, there are cracks visible in the remaining plaster, but they do not form a single large “X” as is characteristic of shear failure of the wall, which is the precursor of collapse. The timber bands on the inside and outside of the wall have served to stop these cracks, and keep the walls from spreading.

In my opinion, from looking at these pictures (without the benefit of being there to look more carefully), these parts of the palace with the timber lacing look quite sound, and not on the verge of collapse, although it suffered the loss of the tops of some of its pagoda towers.

One important survey that I recommend be conducted is to record onto the drawings the locations within the building that have the timber lacing, and inspect it carefully to see its condition. Also, make note of those areas where it does not carry around the whole structure. An important point: the bands at the floor levels are not visible in the photographs, but are of critical importance structurally, as they hold the floor diaphragms to the walls. It would be good to see during the restoration work where they are, and determine if the floor joists extend through the walls, and check to see if there is any decay in the embedded timbers.

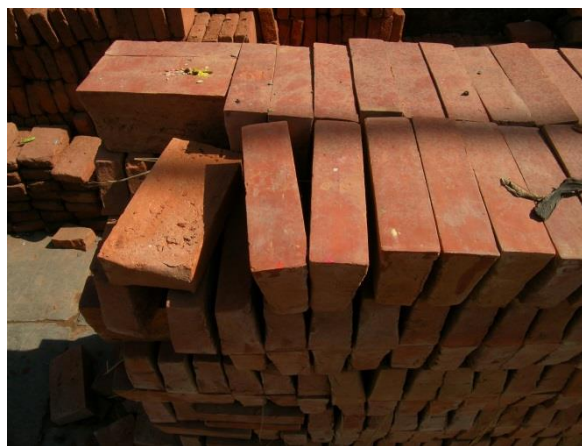
There one particular feature to the traditional construction in Nepal which I wish to address once again – as I had mentioned it in one of my earlier newsgroup emails – is the traditional design of the face bricks. In Nepal, as I have not seen this anywhere else, the specially made face bricks for the more important buildings – temples and palaces – are manufactured with a wedge shape, which allows the mortar bed to be hidden, giving the facades their iconic pencil-thin mortar joints. Kai – perhaps you could help me learn about the history of this, but I have seen it on my trips to Nepal, both at the brick yards, and also at a restoration project of one of the temples next to the **Hanuman Dhoka Palace**, and at the restoration of the **55 Windows Palace**. These are photos I took of them in front of the Hanuman Dhoka Palace in 2005.

While this is both unique, and contributes to the architectural distinction of the Kathmandu buildings, I wish to point out a concern that I have about it from a conservation and earthquake hazard perspective that I have not yet seen discussed. As buildings age, the mortar – particular mud or mud/lime mortars, tend to erode and dry out and deteriorate in the walls. With ordinary rectangular bricks, the structure of the wall may weaken, but the position of the bricks does not change, nor their ability to carry the loads. With the wedge-shaped bricks, a loss of mortar can cause the bricks to rotate slightly, such that their fronts are no longer truly vertical. In ordinary circumstances, this may not be noticed, but as the compressive strength of the mortar weakens, and an earthquake comes, the added force can suddenly cause the face brick layer to pull away from the core of the wall. The shape of the bricks combined with the infrequency of having true bond courses, thus may account for some of the areas of delamination that we see.

It may be worth studying this feature in detail by surveying earthquake damage to try to recognize where this brick shape may have played a role in the damage. When rebuilding the walls, it may be worth considering the addition of a thin wedge or pencil-sized piece of fired ceramic into the mortar joints towards the rear of the bricks so that the vertical compression on the wall would not bear unevenly onto the facebricks. This is just an idea that will need further investigation, but I suggest a solution so that one can see a way to fix the problem without changing the traditional architecture if it can be determined to be a contributing cause of damage to the buildings.
