STONE MASONRY IN CLAY MORTAR with GABION BANDS

An Alternative to timber bands for Rural Stone Masonry in Mud Mortar (SMM)

Information provided by Randolph Langenbach in reply to the request by the DUDBC by emails from Dipendra Aryal, Civil Engineer, and Raju Neupane, Senior Divisional Engineer Dated 27 November 2016.

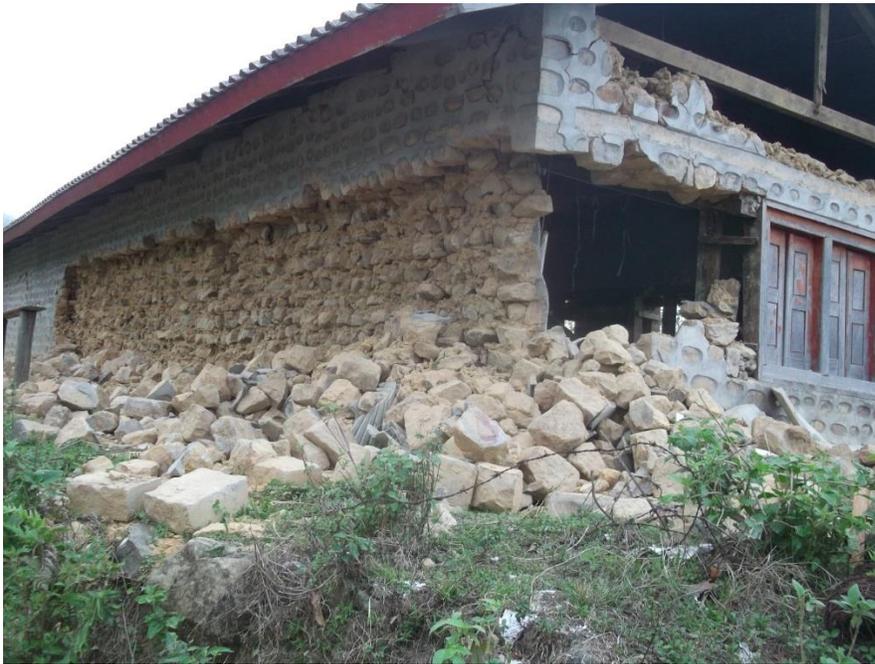
School building in Banakhu, Kavre District showing stone fallen out from beneath RC band. The building was destroyed, and subsequently demolished. Photo by: Jeet Bahadur, Banakhu
